General Information

Make	Toyota	Model	Vios
YOM	2024	Odo Meter Reading	28,072
Registration No.	FAR3255	Chassis No.	PA1B18F34R4243326
CC	1.3	Transmission	CVT
Fuel Type	Gas	Type of Body	Sedan
Colour	Red

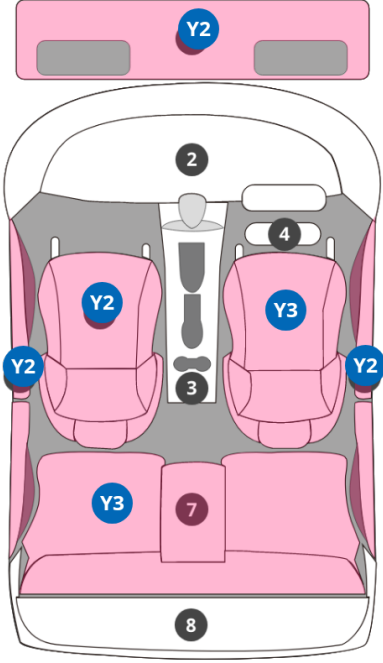
Interior Evaluation : B	Exterior Evaluation : D

<p>a : Cut, Fray d : Loose, Deformed k : Animal Hair s : Smell t : Cigarette Burns x : Defective y : Stain</p>

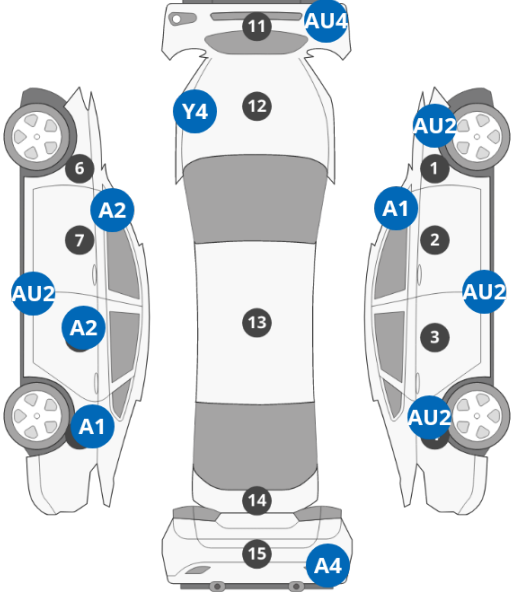
<p>A : Scratch AU : Scratch & Dent B : Modified C : Corrosion G : Stone chip P : Faded S : Rust SC : Rust & Corrosion U : Dent X : Defective Y : Crack, Gap</p>
<p>Remarks Ceiling - Grime - Small / (R) Front Trim - Grime - Small / (R) Front Seat - Grime - Medium / Rear Seat - Grime - Medium / (L) Front Trim - Grime - Small / (L) Front Seat - Grime - Small</p>	<p>Remarks (R) Front Fender - Repair Traces - Yes / Bonnet - Repair Traces - Yes / Front Bumper, Grille, Lamps - Scratch & Dent - Large / (R) Front Fender, Molding - Scratch & Dent - Small / (R) Mirror - Scratch - Minimal / (R) Step, In-panel, Side Spoiler - Scratch & Dent - Small / (R) Rear Fender, Molding - Scratch & Dent - Small / Rear Bumper, Lamps, Panels - Scratch - Large / (L) Rear Fender, Molding - Scratch - Minimal / (L) Rear Door, Molding - Scratch - Small / (L) Mirror - Scratch - Small / (L) Step, In-panel, Side Spoiler - Scratch & Dent - Small / Bonnet, Headlight - Crack, Gap - Large</p>
