General Information

Make	Toyota	Model	Vios
YOM	2024	Odo Meter Reading	14,146
Registration No.	FAR4499	Chassis No.	PA1B18F39R4247906
CC	1.3	Transmission	CVT
Fuel Type	Gas	Type of Body	Sedan
Colour	Black

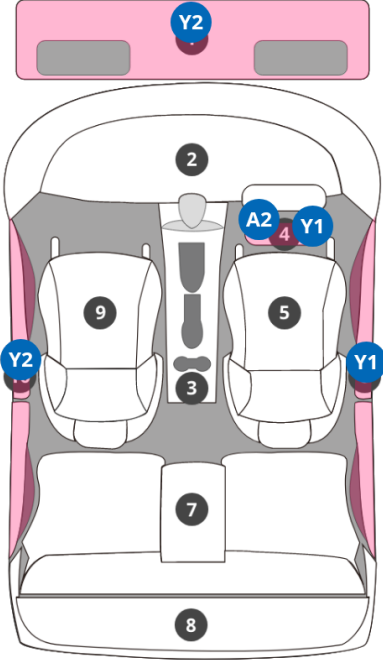
<p>a : Cut, Fray d : Loose, Deformed k : Animal Hair s : Smell t : Cigarette Burns x : Defective y : Stain</p>

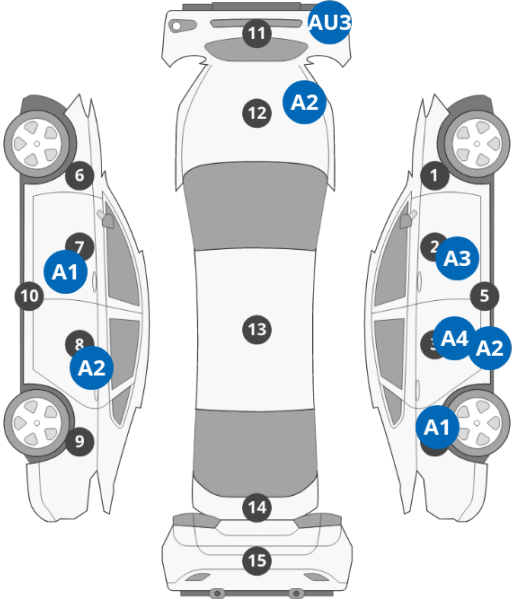
<p>A : Scratch AU : Scratch & Dent B : Modified C : Corrosion G : Stone chip P : Faded S : Rust SC : Rust & Corrosion U : Dent X : Defective Y : Crack, Gap</p>
<p>Remarks Ceiling - Grime - Small / (R) Front Trim - Grime - Minimal / (R) Front Floor Mat - Grime - Minimal / (L) Front Trim - Grime - Small / (L) Front Floor Mat - Cut, Crack - Small</p>	<p>Remarks (L) Rear Door, Molding - Scratch - Small / (L) Front Door, Molding - Scratch - Minimal / (R) Front Door, Molding - Scratch - Medium / (R) Rear Door, Molding - Scratch - Large / (R) Rear Fender, Molding - Scratch - Minimal / (R) Step, In-panel, Side Spoiler - Scratch - Small / Bonnet, Headlight - Scratch - Small / Front Bumper, Grille, Lamps - Scratch & Dent - Medium</p>
Frame Evaluation : A	Functional Evaluation : B
