## General Information

| Make | Toyota | Model | Vios |
| YOM | 2024 | Odo Meter Reading | 11,785 |

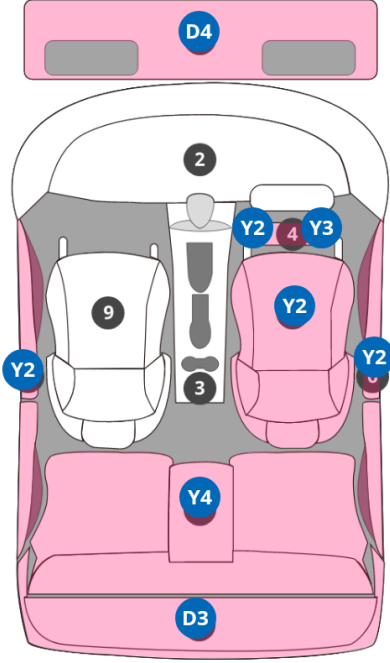
| Interior Evaluation : <b>C</b> | Exterior Evaluation : <b>E</b> |
|---|---|
| <p><b>Remarks</b></p> <p>Ceiling - Loose, Deformed - Large / (R) Front Trim - Grime - Small / (R) Front Seat - Grime - Small / (R) Front Floor Mat - Grime - Medium / Rear Seat - Grime - Large / Trunk Room - Loose, Deformed - Medium / (L) Front Trim - Grime - Small / (L) Front Floor Mat - Grime - Small</p> | <p><b>Remarks</b></p> <p>Front Bumper, Grille, Lamps - Repair mark - Difference in Color / (R) Front Fender, Molding - Scratch &amp; Dent - Small / (R) Front Door, Molding - Scratch - Large / (R) Rear Door, Molding - Scratch - Large / (R) Rear Fender, Molding - Scratch - Small / Trunk Hood, Rear Gate - Scratch - Small / Rear Bumper, Lamps, Panels - Scratch - Small / (L) Rear Fender, Molding - Scratch - Small / (L) Front Door, Molding - Scratch - Small / (L) Rear Door, Molding - Scratch - Small / (L) Mirror - Scratch - Small / (L) Front Fender, Molding - Scratch - Small / Bonnet, Headlight - Scratch - Small / Member (Bolted) - Dent - Yes / Roof - Scratch - Small / Front Bumper, Grille, Lamps - Scratch &amp; Dent - Large</p> |

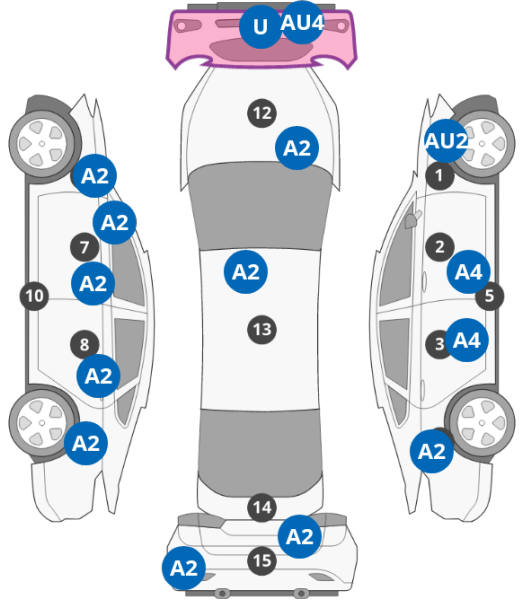
| Inspector Notes |
|---|
| <p>Possible flooding. Foglamps missing. Front bumper right side repaired. missing Toyota Emblem at front. No rear interior lights. Front interior light issue. Trunk floor worked. 3 keys. Without warranty booklet, spare tire, jack, tools and seat cover. engine undercover loose. crack/gap at front bumper.</p> |
