## General Information

<b>Make</b>	Toyota	<b>Model</b>	Vios
<b>YOM</b>	2024	<b>Odo Meter Reading</b>	5,770
<b>Registration No.</b>	FAR5315	<b>Chassis No.</b>	PA1B18F37R4247483
<b>CC</b>	1.3	<b>Transmission</b>	CVT
<b>Fuel Type</b>	Gas	<b>Type of Body</b>	Sedan
<b>Colour</b>	Red Mica Metallic

## Body / Panel Condition

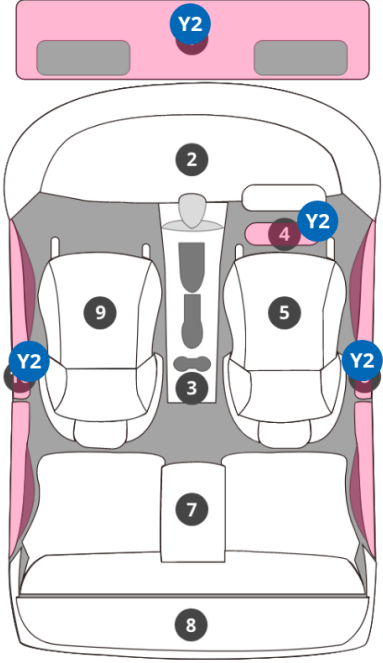
<b>Interior Evaluation :</b> <span style="float: right; color: red; font-weight: bold;">A</span>	<b>Exterior Evaluation :</b> <span style="float: right; color: red; font-weight: bold;">D</span>

<p><b>a</b> : Cut, Fray <b>d</b> : Loose, Deformed <b>k</b> : Animal Hair <b>s</b> : Smell <b>t</b> : Cigarette Burns <b>x</b> : Defective <b>y</b> : Stain</p>

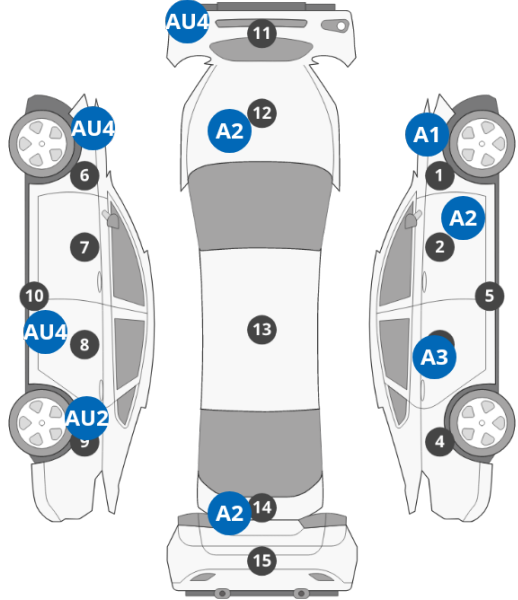
<p><b>A</b> : Scratch <b>AU</b> : Scratch &amp; Dent <b>B</b> : Modified <b>C</b> : Corrosion <b>G</b> : Stone chip <b>P</b> : Faded <b>S</b> : Rust <b>SC</b> : Rust &amp; Corrosion <b>U</b> : Dent <b>X</b> : Defective <b>Y</b> : Crack, Gap</p>
<p><b>Remarks</b> Ceiling - Grime - Small / (R) Front Trim - Grime - Small / (R) Front Floor Mat - Grime - Small / (L) Front Trim - Grime - Small</p>	<p><b>Remarks</b> Front Bumper, Grille, Lamps - Scratch &amp; Dent - Large / (L) Front Fender, Molding - Scratch &amp; Dent - Large / (R) Front Fender, Molding - Scratch - Minimal / (R) Rear Door, Molding - Scratch - Medium / (R) Front Door, Molding - Scratch - Small / Trunk Hood, Rear Gate - Scratch - Small / (L) Rear Fender, Molding - Scratch &amp; Dent - Small / (L) Rear Door, Molding - Scratch &amp; Dent - Large / Bonnet, Headlight - Scratch - Small</p>
