General Information

Make	Toyota	Model	Lite Ace
YOM	2024	Odo Meter Reading	1,862
Registration No.	FAR6518	Chassis No.	MHKU3FE10RK007798
CC	1.5	Transmission	M/T
Fuel Type	Gas	Type of Body	Utility Passenger
Colour	White

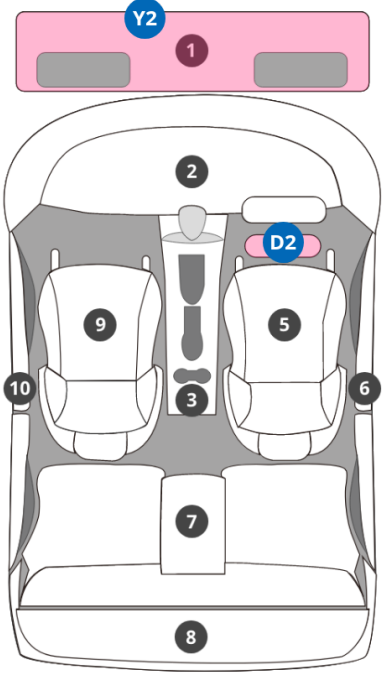
<p>a : Cut, Fray d : Loose, Deformed k : Animal Hair s : Smell t : Cigarette Burns x : Defective y : Stain</p>

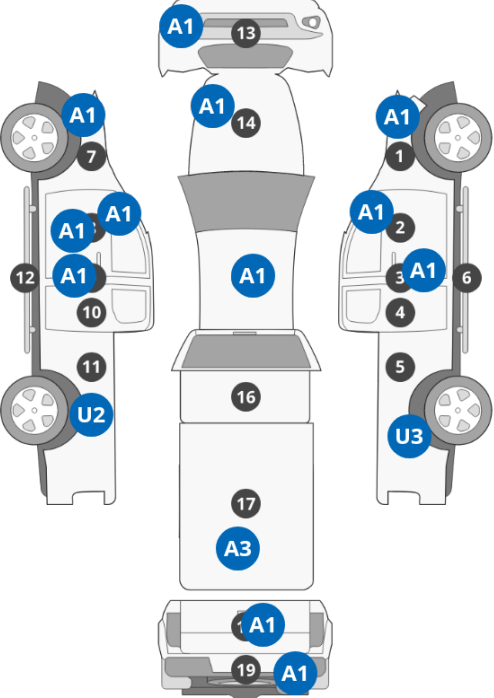
<p>A : Scratch AU : Scratch & Dent B : Modified C : Corrosion G : Stone chip P : Faded S : Rust SC : Rust & Corrosion U : Dent X : Defective Y : Crack, Gap</p>
<p>Remarks (L) Front Floor Mat - Worked - Small / Ceiling - Grime - Small</p>	<p>Remarks (R) Front Fender, Molding - Scratch - Minimal / (R) Mirror - Scratch - Minimal / (R) Front Door, Molding - Scratch - Minimal / (R) Side Gate - Dent - Medium / Rear Bumper, Lamps, Panels - Scratch - Minimal / Rear Gate - Scratch - Minimal / Cargo Bed Floor - Scratch - Medium / (L) Side Gate - Dent - Small / (L) Mirror - Scratch - Minimal / (L) Front Door, Molding - Scratch - Minimal / (L) Center Panel - Scratch - Minimal / (L) Front Fender, Molding - Scratch - Minimal / Front Bumper, Grille, Lamps - Scratch - Minimal / Front Panel - Scratch - Minimal / Roof - Scratch - Minimal</p>
