## General Information

| Make | Toyota | Model | Vios |
| Registration No. | FAR8190 | Chassis No. | PA1B18F30R4256168 |

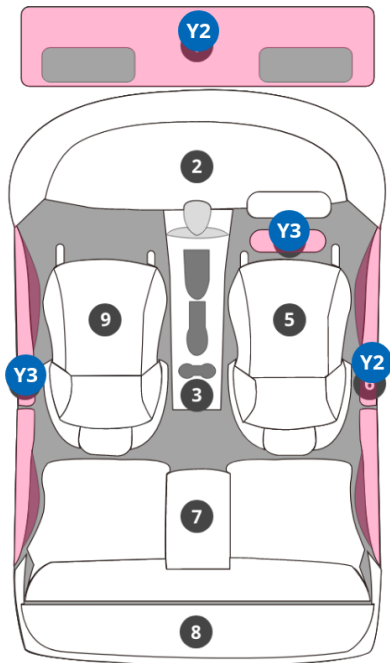
| Interior Evaluation : <b>B</b> | Exterior Evaluation : <b>C</b> |
|---|---|
| <b>Remarks</b><br>Ceiling - Grime - Small / (R) Front Trim - Grime - Small / Mat Other - Grime - Medium / (L) Front Trim - Grime - Medium | <b>Remarks</b><br>(R) Rear Door - Repair Traces - Yes / (L) Mirror - Scratch - Small / (L) Front Fender, Molding - Scratch - Small / (R) Front Fender, Molding - Scratch - Medium / Front Bumper, Grille, Lamps - Scratch - Medium / (R) Mirror - Scratch - Small / (R) Front Door, Molding - Scratch - Medium / (R) Rear Door, Molding - Scratch - Medium / (R) Rear Fender, Molding - Scratch - Small / Rear Bumper, Lamps, Panels - Scratch & Dent - Small / (L) Rear Fender, Molding - Scratch - Small / (L) Front Door, Molding - Scratch - Small |
