## General Information

| Make | Suzuki | Model | Dzire |

## Body / Panel Condition

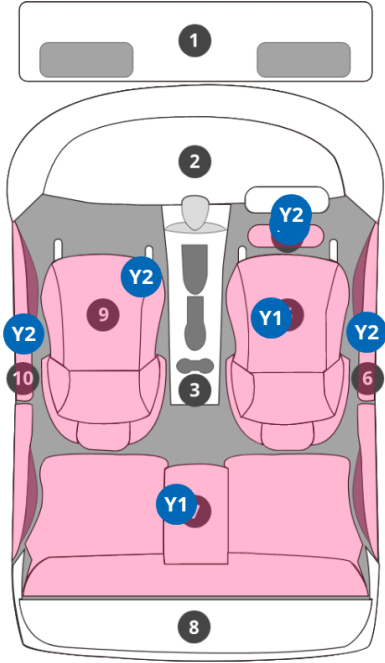
| Interior Evaluation : <b>B</b> | Exterior Evaluation : <b>C</b> |
|---|---|
| <b>Remarks</b><br>(R) Front Trim - Grime - Small / (L) Front Trim - Grime - Small / (R) Front Seat - Grime - Minimal / (L) Front Seat - Grime - Small / (L) Front Floor Mat - Worked - Small / (R) Front Floor Mat - Grime - Small / Rear Seat - Grime - Minimal | <b>Remarks</b><br>(R) Front Fender, Molding - Scratch - Minimal / (R) Front Door, Molding - Scratch - Minimal / (R) Step, In-panel, Side Spoiler - Scratch - Small / (R) Mirror - Scratch - Minimal / (R) Rear Fender, Molding - Scratch - Small / (R) Rear Door, Molding - Scratch - Small / Rear Bumper, Lamps, Panels - Scratch - Small / Trunk Hood, Rear Gate - Scratch - Minimal / (L) Rear Fender, Molding - Scratch - Small / (L) Rear Door, Molding - Scratch - Small / (L) Step, In-panel, Side Spoiler - Scratch - Small / (L) Front Door, Molding - Scratch - Minimal / (L) Mirror - Scratch - Minimal / (L) Front Fender, Molding - Scratch - Small / Front Bumper, Grille, Lamps - Scratch & Dent - Medium / Bonnet, Headlight - Scratch - Medium / Roof - Scratch - Minimal |

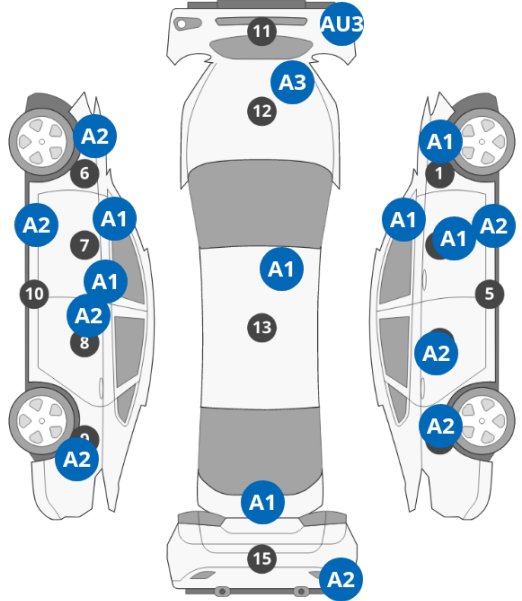
| Inspector Notes |
|---|
| with warranty booklet, no jack, with tools, with spare tire, no LTO plate, scratches on tail light, battery for replacement |
