## General Information

| Make | Suzuki | Model | Dzire |
| YOM | 2024 | Odo Meter Reading | 1,663 |

## Body / Panel Condition

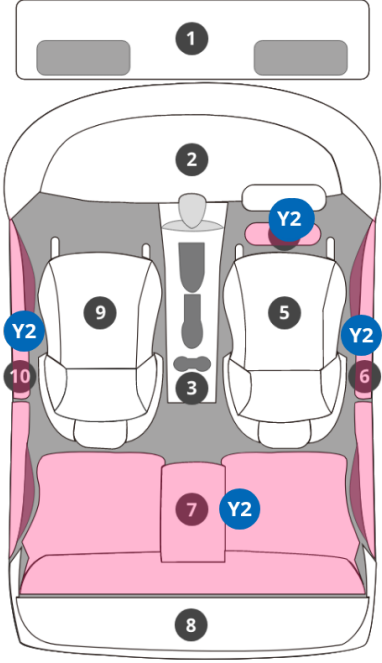
| Interior Evaluation : <b>B</b> | Exterior Evaluation : <b>B</b> |
|---|---|
| <p><b>Remarks</b><br/>Rear Seat - Grime - Small / Mat Other - Grime - Small / (L) Front Floor Mat - Worked - Small / (L) Front Trim - Grime - Small / (R) Front Trim - Grime - Small / (R) Front Floor Mat - Grime - Small</p> | <p><b>Remarks</b><br/>Bonnet - Repair Traces - Yes / (R) Front Fender, Molding - Scratch - Minimal / (R) Front Door, Molding - Scratch - Minimal / (R) Mirror - Scratch - Minimal / (R) Rear Door, Molding - Scratch - Minimal / (R) Rear Fender, Molding - Scratch - Minimal / Rear Bumper, Lamps, Panels - Scratch - Minimal / Trunk Hood, Rear Gate - Dent - Small / (L) Rear Fender, Molding - Scratch - Minimal / (L) Rear Door, Molding - Scratch - Minimal / (L) Front Door, Molding - Scratch - Minimal / (L) Mirror - Scratch - Minimal / (L) Front Fender, Molding - Scratch - Minimal / Bonnet, Headlight - Scratch - Small / Front Bumper, Grille, Lamps - Scratch - Minimal / Roof - Scratch - Minimal</p> |

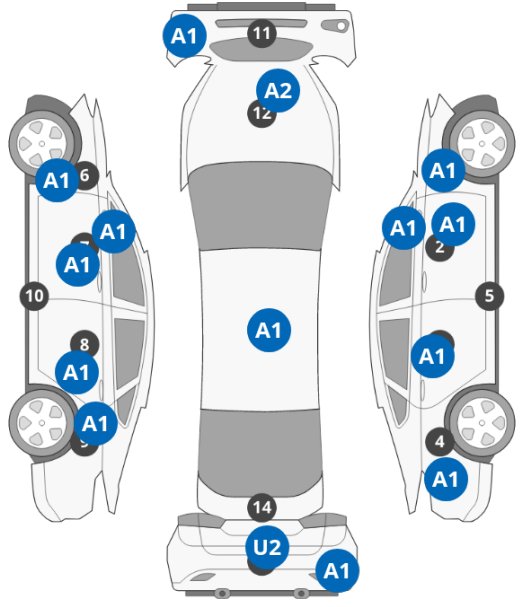
| Inspector Notes |
|---|
| with warranty booklet, with jack and tools, with spare tire, no LTO plate, scratches on tail light |
