## General Information

| Make | Suzuki | Model | Ertiga |

## Body / Panel Condition

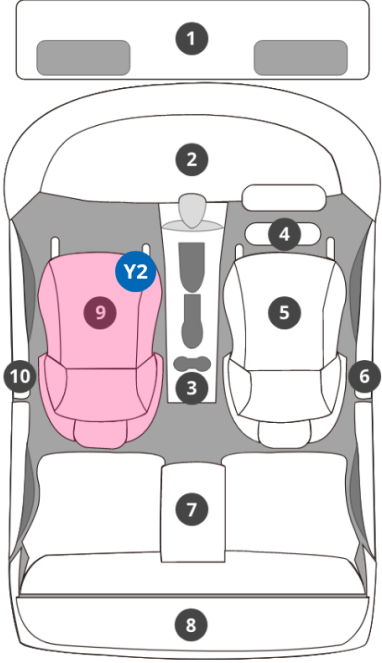
| Interior Evaluation : <b>A</b> | Exterior Evaluation : <b>B</b> |
|---|---|
| <b>Remarks</b><br>(L) Front Seat - Grime - Small | <b>Remarks</b><br>(R) Front Fender, Molding - Scratch - Minimal / (R) Step, In-panel, Side Spoiler - Scratch & Dent - Medium / (R) Front Door, Molding - Scratch - Minimal / (R) Rear Door, Molding - Scratch - Minimal / (R) Mirror - Scratch - Minimal / (R) Rear Fender, Molding - Scratch & Dent - Small / Rear Bumper, Lamps, Panels - Scratch - Minimal / Trunk Hood, Rear Gate - Scratch - Minimal / (L) Rear Fender, Molding - Scratch - Minimal / (L) Rear Door, Molding - Scratch - Minimal / (L) Front Door, Molding - Scratch - Minimal / (L) Mirror - Scratch - Minimal / (L) Front Fender, Molding - Scratch - Minimal / Front Bumper, Grille, Lamps - Scratch - Minimal / Bonnet, Headlight - Scratch - Minimal / Roof - Scratch - Minimal |

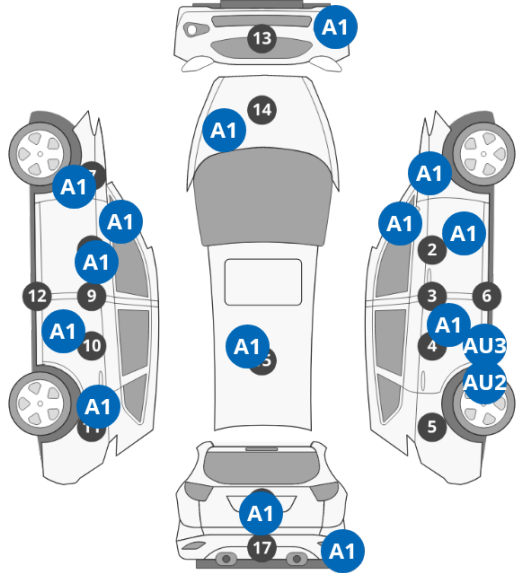
| Inspector Notes |
|---|
| no warranty booklet, with jack and tools, with spare tire, no LTO plate, scratches on tail light |
