## General Information

| Make | Toyota | Model | Vios |
| Registration No. | GBC1058 | Chassis No. | PA1B18F39P4232268 |

## Body / Panel Condition

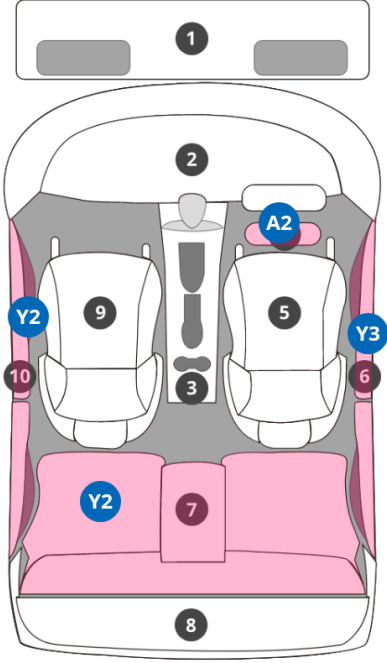
| Interior Evaluation : <b>B</b> | Exterior Evaluation : <b>E</b> |
| <p><b>Remarks</b><br/>(L) Front Floor Mat - Cut, Crack - Small / Rear Seat - Grime - Small / (L) Front Trim - Grime - Small / (R) Front Trim - Grime - Medium</p> | <p><b>Remarks</b><br/>(R) Front Door - Repair Traces - Yes / (R) Step - Repair Traces - Yes / (R) Front Fender - Repair Traces - Yes / (R) Rear Door - Repair Traces - Yes / Bonnet, Headlight - Dent - Small / (R) Front Door, Molding - Scratch &amp; Dent - Medium / (R) Rear Door, Molding - Scratch &amp; Dent - Large / Front Bumper, Grille, Lamps - Crack, Gap - Medium / (L) Step, In-panel, Side Spoiler - Dent - Large / (L) Front Door, Molding - Dent - Small / Roof - Dent - Small / Rear Bumper, Lamps, Panels - Scratch - Small / Trunk Hood, Rear Gate - Scratch - Small / (L) Rear Fender, Molding - Scratch - Small / (R) Rear Fender, Molding - Scratch - Small / (L) Front Fender, Molding - Scratch - Small / (R) Front Fender, Molding - Scratch - Small / (L) Mirror - Scratch - Small</p> |
