## General Information

| Make | Toyota | Model | Vios |
| Registration No. | FAQ4039 | Chassis No. | PA1B18F32P4233388 |

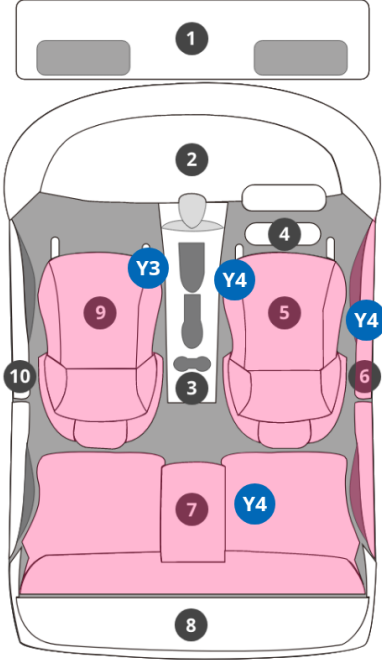
| Interior Evaluation : <b>C</b> | Exterior Evaluation : <b>B</b> |
|---|---|
| <b>Remarks</b><br>(L) Front Seat - Grime - Medium / (R) Front Seat - Grime - Large / Rear Seat - Grime - Large / (R) Front Trim - Grime - Large | <b>Remarks</b><br>Front Bumper, Grille, Lamps - Scratch - Medium / Rear Bumper, Lamps, Panels - Scratch & Dent - Medium / (R) Rear Door, Molding - Scratch - Small / (R) Front Door, Molding - Scratch - Small / (R) Front Fender, Molding - Scratch - Small / Bonnet, Headlight - Dent - Minimal / Trunk Hood, Rear Gate - Scratch - Minimal |
