## General Information

| Make | Toyota | Model | Vios |
| YOM | 2025 | Odo Meter Reading | 11,796 |
| Registration No. | FAS5374 | Chassis No. | PA1B18F38R4279861 |

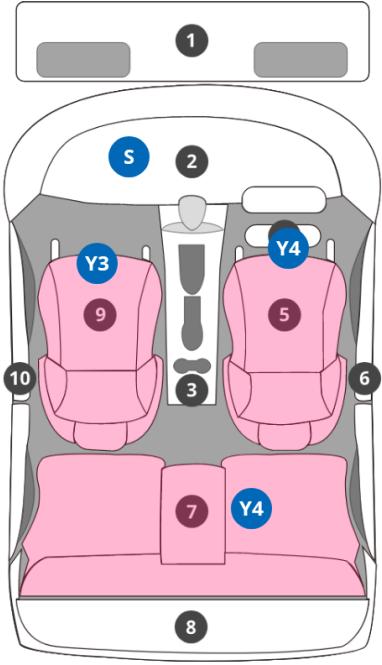
| Interior Evaluation : <span style="color: red;">C</span> | Exterior Evaluation : <span style="color: red;">E</span> |
| <b>Remarks</b><br>Rear Seat - Grime - Large / (R) Front Seat - Grime - Large / (L) Front Seat - Grime - Medium / Overall Interior - Smell - Yes | <b>Remarks</b><br>(R) Front Fender, Molding - Scratch & Dent - Large / (R) Front Door, Molding - Scratch & Dent - Large / Front Bumper, Grille, Lamps - Scratch & Dent - Large / Bonnet, Headlight - Crack, Gap - Large / (L) Front Door, Molding - Crack, Gap - Small / Rear Bumper, Lamps, Panels - Scratch - Medium / (L) Rear Fender, Molding - Scratch - Small / (L) Rear Door, Molding - Scratch - Minimal / Trunk Hood, Rear Gate - Scratch - Minimal / (R) Rear Fender, Molding - Scratch - Small / (R) Rear Door, Molding - Scratch - Small / (R) Step, In-panel, Side Spoiler - Scratch & Dent - Large / (L) Front Fender, Molding - Scratch - Minimal |
