General Information

Make	Toyota	Model	Vios
YOM	2023	Odo Meter Reading	23,173
Registration No.	NHJ6629	Chassis No.	PA1B18F37P4220572
CC	1.3	Transmission	CVT
Fuel Type	Gas	Type of Body	Sedan
Colour	Black

Body / Panel Condition

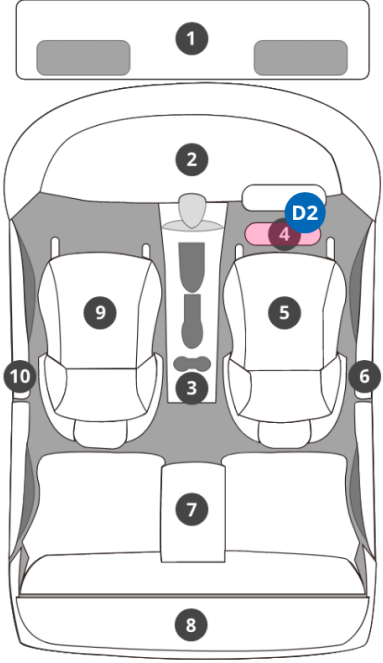
Interior Evaluation : A	Exterior Evaluation : E

<p>a : Cut, Fray d : Loose, Deformed k : Animal Hair s : Smell t : Cigarette Burns x : Defective y : Stain</p>

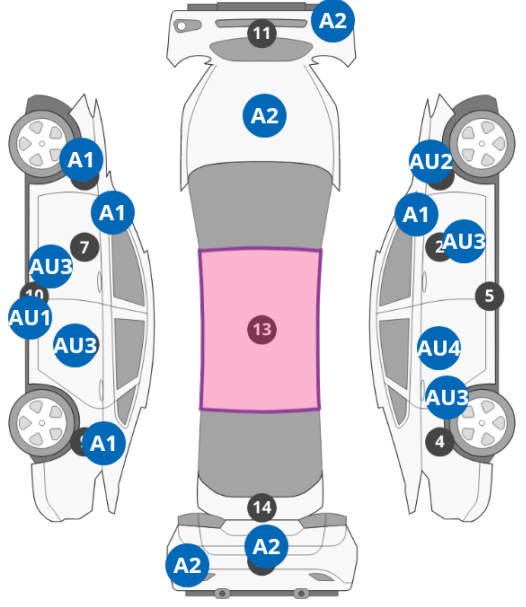
<p>A : Scratch AU : Scratch & Dent B : Modified C : Corrosion G : Stone chip P : Faded S : Rust SC : Rust & Corrosion U : Dent X : Defective Y : Crack, Gap</p>
Remarks (L) Front Floor Mat - Worked - Small	Remarks Roof - Repair Traces - Yes / (L) Front Door, Molding - Scratch & Dent - Medium / Roof - Repair mark - Yes / (L) Rear Door, Molding - Scratch & Dent - Medium / (L) Step, In-panel, Side Spoiler - Scratch & Dent - Minimal / (L) Mirror - Scratch - Minimal / (L) Front Fender, Molding - Scratch - Minimal / Bonnet, Headlight - Scratch - Small / Front Bumper, Grille, Lamps - Scratch - Small / (R) Front Fender, Molding - Scratch & Dent - Small / (R) Mirror - Scratch - Minimal / (R) Front Door, Molding - Scratch & Dent - Medium / (R) Rear Door, Molding - Scratch & Dent - Large / (R) Rear Fender, Molding - Scratch & Dent - Medium / Trunk Hood, Rear Gate - Scratch - Small / Rear Bumper, Lamps, Panels - Scratch - Small / (L) Rear Fender, Molding - Scratch - Minimal

Inspector Notes
With LTO plate and Sparetire and Jack, Incomplete Tools, No warranty booklet, No spare key and scratch headlight and tail light.
