## General Information

| Make | Toyota | Model | Vios |
| YOM | 2023 | Mileage | 6,597 |
| Registration No. | NHI1855 | Chassis No. | PA1B18F30P4203323 |

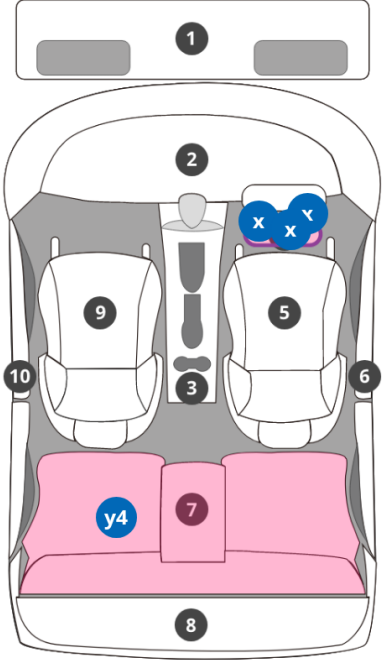
| Interior Evaluation : <b>C</b> | Exterior Evaluation : <b>A</b> |
|---|---|
| <p><b>Remarks</b><br/>(L) Front Floor Mat - Missing - Yes / (R) Front Floor Mat - Missing - Yes / Mat Other - Missing - Yes / Rear Seat - Grime - Large</p> | <p><b>Remarks</b><br/>Trunk Hood, Rear Gate - Dent - Small / Rear Bumper, Lamps, Panels - Dent - Minimal</p> |
