General Information

Make	Toyota	Model	Vios
YOM	2024	Odo Meter Reading	25,803
Registration No.	DBN8846	Chassis No.	PA1B18F31P4231857
CC	1.3	Transmission	CVT
Fuel Type	Gas	Type of Body	Sedan
Colour	Red

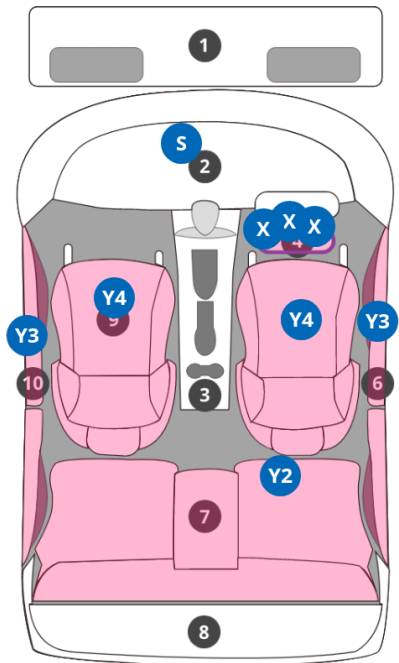
Interior Evaluation : C	Exterior Evaluation : E

<p>a : Cut, Fray d : Loose, Deformed k : Animal Hair s : Smell t : Cigarette Burns x : Defective y : Stain</p>

<p>A : Scratch AU : Scratch & Dent B : Modified C : Corrosion G : Stone chip P : Faded S : Rust SC : Rust & Corrosion U : Dent X : Defective Y : Crack, Gap</p>
<p>Remarks Overall Interior - Worn as per age - Yes / Overall Interior - Smell - Yes / Mat Other - Missing - Yes / (L) Front Floor Mat - Missing - Yes / (R) Front Floor Mat - Missing - Yes / (R) Front Seat - Grime - Large / (L) Front Seat - Grime - Large / (L) Front Trim - Grime - Medium / (R) Front Trim - Grime - Medium / Rear Seat - Grime - Small</p>	<p>Remarks Roof - Scratch & Dent - Medium / (L) Rear Door, Molding - Dent - Small / (L) Front Fender, Molding - Scratch - Small / (L) Front Door, Molding - Scratch - Small / (L) Rear Fender, Molding - Scratch - Small / Trunk Hood, Rear Gate - Scratch & Dent - Large / Rear Bumper, Lamps, Panels - Scratch & Dent - Large / (R) Rear Door, Molding - Scratch & Dent - Small / (R) Step, In-panel, Side Spoiler - Scratch - Medium / (R) Front Door, Molding - Scratch - Small / (R) Front Fender, Molding - Scratch - Small / Front Bumper, Grille, Lamps - Scratch - Large / (R) Rear Fender, Molding - Scratch - Minimal</p>
