General Information

Body / Panel Condition

Overall Evaluation :

B

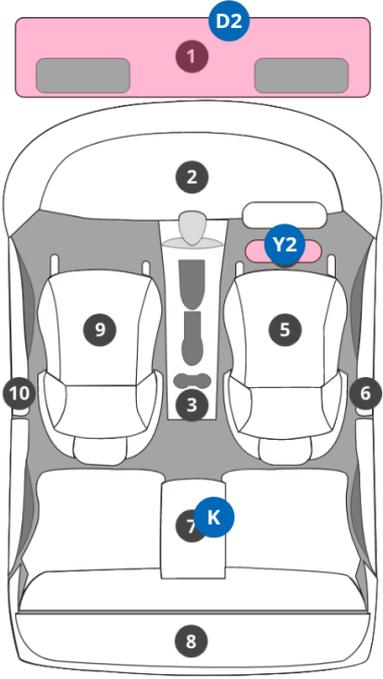
<p>a : Cut, Fray d : Loose, Deformed k : Animal Hair s : Smell t : Cigarette Burns x : Defective y : Stain</p>

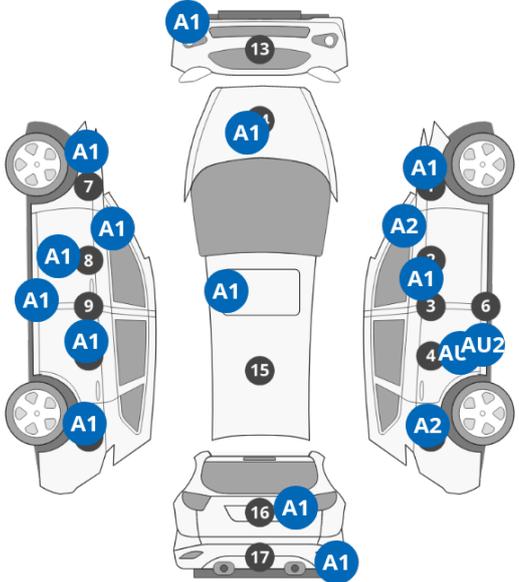
<p>A : Scratch AU : Scratch & Dent B : Modified C : Corrosion G : Stone chip P : Faded S : Rust SC : Rust & Corrosion U : Dent X : Defective Y : Crack, Gap</p>
<p>Remarks Overall Interior - Animal Hair - Yes / Ceiling - Crinkle - Small / (R) Front Floor Mat - Grime - Small</p>	<p>Remarks (R) Front Fender, Molding - Scratch - Minimal / (R) Front Door, Molding - Scratch - Minimal / (R) Mirror - Scratch - Small / (R) Rear Door, Molding - Scratch & Dent - Medium / (R) Step, In-panel, Side Spoiler - Scratch & Dent - Small / (R) Rear Fender, Molding - Scratch - Small / Rear Bumper, Lamps, Panels - Scratch - Minimal / Trunk Hood, Rear Gate - Scratch - Minimal / (L) Rear Fender, Molding - Scratch - Minimal / (L) Step, In-panel, Side Spoiler - Scratch - Minimal / (L) Rear Door, Molding - Scratch - Minimal / (L) Front Door, Molding - Scratch - Minimal / (L) Mirror - Scratch - Minimal / (L) Front Fender, Molding - Scratch - Minimal / Front Bumper, Grille, Lamps - Scratch - Minimal / Bonnet, Headlight - Scratch - Minimal / Roof - Scratch - Minimal</p>
