## General Information

| Make | Toyota | Model | Fortuner |
| YOM | 2023 | Mileage | 9,213 |
| Registration No. | CAZ7654 | Chassis No. | MHFCB8GS9N0528550 |

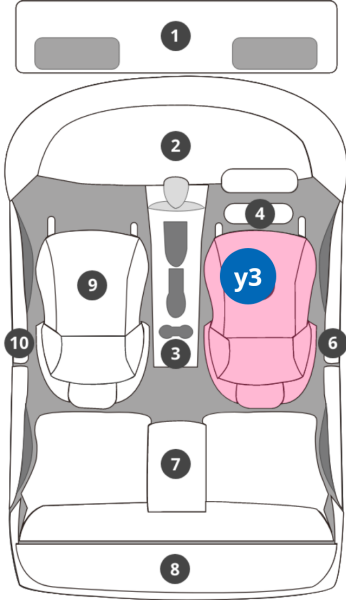
| Interior Evaluation : <b>B</b> | Exterior Evaluation : <b>B</b> |
|---|---|
| <b>Remarks</b><br>(R) Front Seat - Grime - Medium | <b>Remarks</b><br>(L) Rear Fender - Repair Traces - Yes / (L) Rear Fender, Molding - Repair mark - Yes / Front Bumper, Grille, Lamps - Repair mark - Yes / Front Bumper, Grille, Lamps - Crack, Gap - Medium / Rear Bumper, Lamps, Panels - Scratch & Dent - Minimal |
