## General Information

| <b>Make</b> | Toyota | <b>Model</b> | Fortuner |
| <b>Registration No.</b> | EAJ7122 | <b>Chassis No.</b> | MHFJB3GS4R1108088 |

## Body / Panel Condition

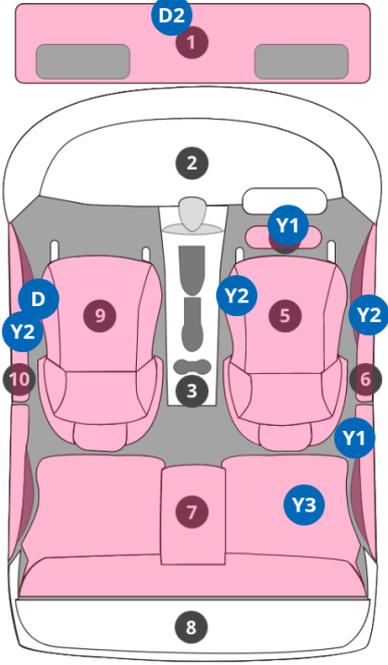
| <b>Interior Evaluation :</b> <span style="float: right;"><b>B</b></span> | <b>Exterior Evaluation :</b> <span style="float: right;"><b>C</b></span> |

| <p><b>Remarks</b><br/>Rear Seat - Grime - Medium / (R) Front Seat - Grime - Small / (L) Front Seat - Worn - Yes / (R) Front Trim - Grime - Small / (L) Front Trim - Grime - Small / (R) Rear Trim - Grime - Minimal / (R) Front Floor Mat - Grime - Minimal / Ceiling - Crinkle - Small</p> | <p><b>Remarks</b><br/>(R) Front Fender, Molding - Scratch &amp; Dent - Small / (R) Mirror - Scratch - Small / (R) Front Door, Molding - Scratch - Minimal / (R) Rear Door, Molding - Scratch - Minimal / (R) Rear Fender, Molding - Scratch - Minimal / Rear Bumper, Lamps, Panels - Scratch - Minimal / Trunk Hood, Rear Gate - Repair mark - Yes / Trunk Hood, Rear Gate - Dent - Minimal / (L) Rear Fender, Molding - Scratch - Minimal / (L) Rear Door, Molding - Scratch - Small / (L) Front Door, Molding - Scratch - Minimal / (L) Mirror - Scratch - Minimal / (L) Front Fender, Molding - Scratch - Minimal / Front Bumper, Grille, Lamps - Repair mark - Yes / Front Bumper, Grille, Lamps - Scratch &amp; Dent - Small / Bonnet, Headlight - Scratch - Small / Roof - Scratch - Small</p> |

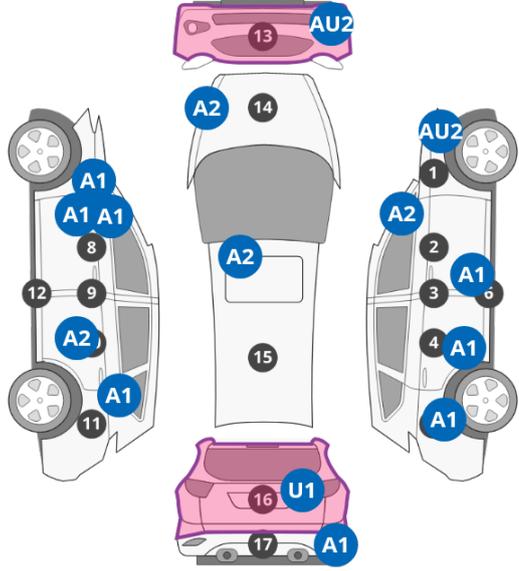
| <p>with warranty booklet, with jack and tools, with spare tire, with LTO plate, scratches on tail light</p> |
