General Information

Make	Suzuki	Model	APV
YOM	2023	Odo Meter Reading	35,253
Registration No.	NEE3957	Chassis No.	MHYDN71C6PJ402692
CC	1.6	Transmission	M/T
Fuel Type	Gas	Type of Body	Van
Colour	White

Body / Panel Condition

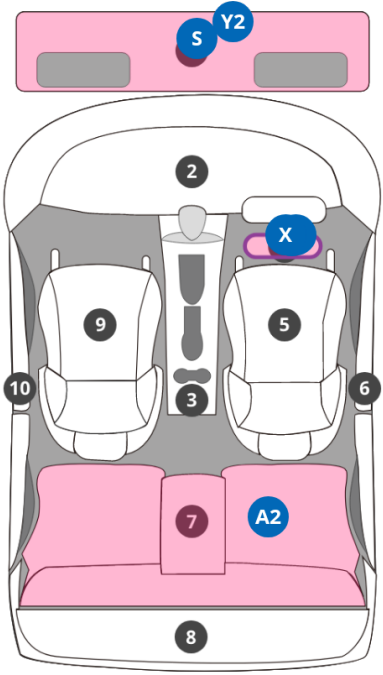
Interior Evaluation : B	Exterior Evaluation : B

<p>a : Cut, Fray d : Loose, Deformed k : Animal Hair s : Smell t : Cigarette Burns x : Defective y : Stain</p>

<p>A : Scratch AU : Scratch & Dent B : Modified C : Corrosion G : Stone chip P : Faded S : Rust SC : Rust & Corrosion U : Dent X : Defective Y : Crack, Gap</p>
<p>Remarks (L) Front Floor Mat - Missing - Yes / (R) Front Floor Mat - Missing - Yes / Mat Other - Missing - Yes / Rear Seat - Cut, Crack - Small / Overall Interior - Smell - Yes / Ceiling - Grime - Small</p>	<p>Remarks (L) Step, In-panel, Side Spoiler - Scratch & Dent - Small / (L) Rear Fender, Molding - Scratch - Minimal / (L) Rear Door, Molding - Scratch - Minimal / (L) Front Door, Molding - Scratch - Small / (L) Mirror - Scratch - Minimal / Bonnet, Headlight - Scratch - Minimal / Front Bumper, Grille, Lamps - Scratch - Small / (R) Mirror - Scratch - Minimal / (R) Front Fender, Molding - Scratch - Minimal / (R) Rear Door, Molding - Scratch & Dent - Small / (R) Front Door, Molding - Scratch - Minimal / (R) Rear Fender, Molding - Scratch - Minimal / Trunk Hood, Rear Gate - Scratch - Minimal / Rear Bumper, Lamps, Panels - Scratch & Dent - Small / Roof - Scratch & Dent - Small</p>
