## General Information

| Make | Toyota | Model | Vios |
| Registration No. | FAQ3503 | Chassis No. | PA1B18F35P4231537 |

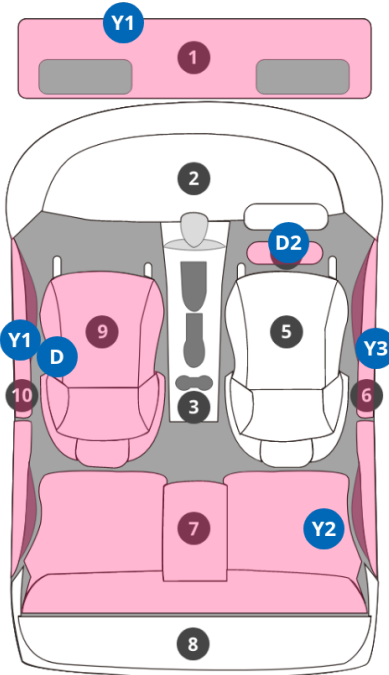
| Interior Evaluation : <span style="color: red; font-weight: bold;">B</span> | | Exterior Evaluation : <span style="color: red; font-weight: bold;">D</span> | |
| <p><b>Remarks</b></p> <p>Rear Seat - Grime - Small / (L) Front Seat - Worn - Yes / (R) Front Trim - Grime - Medium / (L) Front Trim - Grime - Minimal / Ceiling - Grime - Minimal / (L) Front Floor Mat - Worked - Small</p> | | <p><b>Remarks</b></p> <p>(R) Front Fender, Molding - Scratch - Small / (R) Mirror - Scratch - Minimal / (R) Step, In-panel, Side Spoiler - Scratch - Small / (R) Front Door, Molding - Scratch - Minimal / (R) Rear Door, Molding - Scratch - Minimal / (R) Rear Fender, Molding - Scratch - Small / Rear Bumper, Lamps, Panels - Scratch - Small / Trunk Hood, Rear Gate - Scratch - Small / (L) Rear Fender, Molding - Scratch - Minimal / (L) Rear Door, Molding - Scratch - Small / (L) Front Fender, Molding - Scratch &amp; Dent - Large / (L) Front Door, Molding - Scratch &amp; Dent - Medium / (L) Mirror - Crack - Damaged / (L) Mirror - Scratch - Minimal / Member (Bolted) - Dent - Yes / Front Bumper, Grille, Lamps - Scratch - Small / Bonnet, Headlight - Scratch - Minimal</p> | |

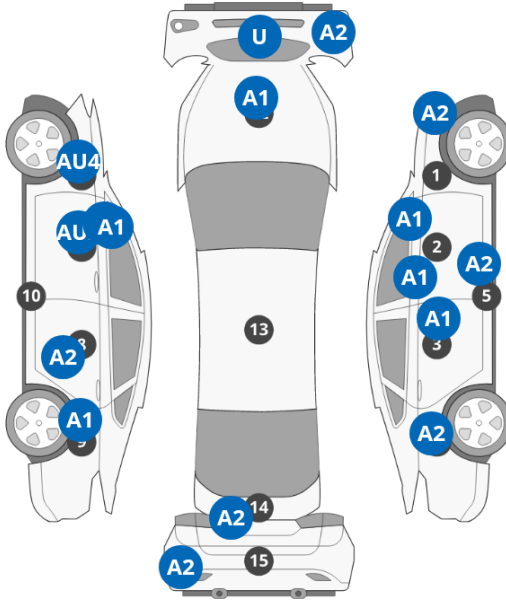
no warranty booklet, no jack and tools, with spare tire, with LTO plate, scratches on tail light, damaged left side mirror
