General Information

Make	Toyota	Model	Vios
YOM	2025	Odo Meter Reading	5,240
Registration No.	NKJ4648	Chassis No.	PA1B18F32R4265454
CC	1.3	Transmission	CVT
Fuel Type	Gas	Type of Body	Sedan
Colour	Blue

Body / Panel Condition

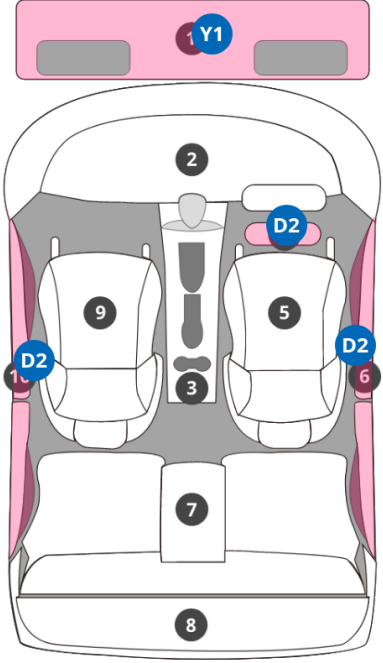
Interior Evaluation : A	Exterior Evaluation : C

<p>a : Cut, Fray d : Loose, Deformed k : Animal Hair s : Smell t : Cigarette Burns x : Defective y : Stain</p>

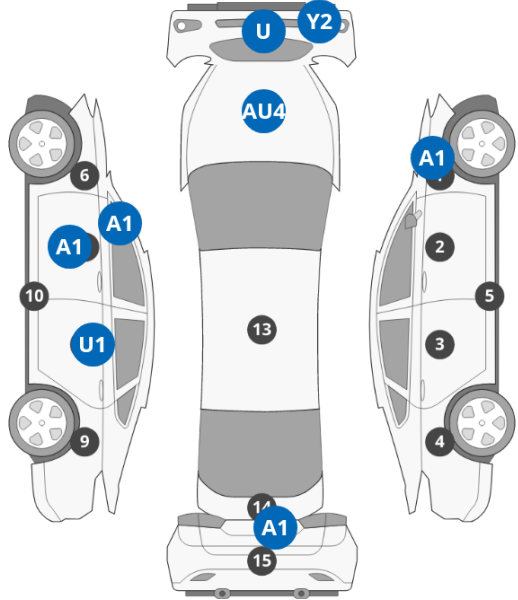
<p>A : Scratch AU : Scratch & Dent B : Modified C : Corrosion G : Stone chip P : Faded S : Rust SC : Rust & Corrosion U : Dent X : Defective Y : Crack, Gap</p>
<p>Remarks (L) Front Floor Mat - Worked - Small / (L) Front Trim - Worked - Small / (R) Front Trim - Worked - Small / Ceiling - Grime - Minimal</p>	<p>Remarks (L) Rear Door, Molding - Dent - Minimal / (L) Front Door, Molding - Scratch - Minimal / (L) Mirror - Scratch - Minimal / Member (Bolted) - Dent - Yes / Bonnet, Headlight - Scratch & Dent - Large / Front Bumper, Grille, Lamps - Crack, Gap - Small / Trunk Hood, Rear Gate - Scratch - Minimal / (R) Front Fender, Molding - Scratch - Minimal</p>
Frame Evaluation : A	Functional Evaluation : A
<p>Remarks Defects not found</p>	<p>Remarks Audio, Radio - Issue - Yes</p>
