## General Information

| Make | Toyota | Model | Innova |

## Body / Panel Condition

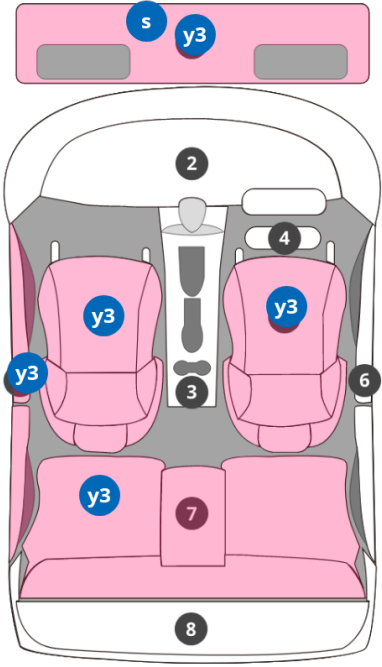
| <b>Remarks</b><br>Ceiling - Grime - Medium / Overall Interior - Smell - Yes / (L) Front Trim - Grime - Medium / (L) Front Seat - Grime - Medium / Rear Seat - Grime - Medium | <b>Remarks</b><br>(R) Rear Door, Molding - Scratch & Dent - Large / (R) Front Door, Molding - Scratch & Dent - Large / (R) Front Fender, Molding - Dent - Small / (R) Rear Fender, Molding - Dent - Minimal / (L) Rear Door, Molding - Scratch & Dent - Medium / (L) Front Door, Molding - Scratch & Dent - Small / (L) Step, In-panel, Side Spoiler - Scratch & Dent - Small / (R) Step, In-panel, Side Spoiler - Scratch & Dent - Medium / Bonnet, Headlight - Scratch - Small / Front Bumper, Grille, Lamps - Scratch & Dent - Large |
