General Information

Make	Mitsubishi	Model	Xpander
YOM	2023	Odo Meter Reading	14,314
Registration No.	NIC8476	Chassis No.	MK2LRNC1WPN001275
CC	1.5	Transmission	A/T
Fuel Type	Gas	Type of Body	Wagon
Colour	Silver

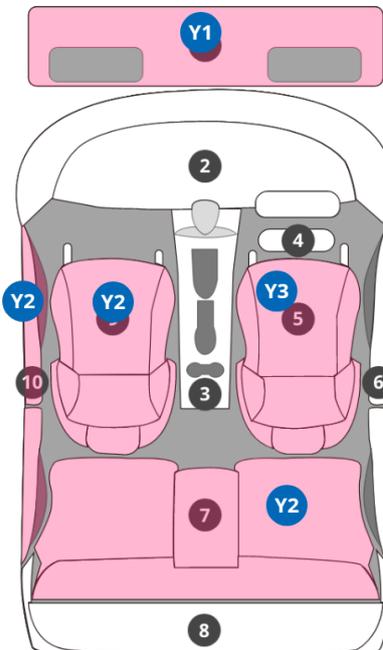
<p>a : Cut, Fray d : Loose, Deformed k : Animal Hair s : Smell t : Cigarette Burns x : Defective y : Stain</p>

<p>A : Scratch AU : Scratch & Dent B : Modified C : Corrosion G : Stone chip P : Faded S : Rust SC : Rust & Corrosion U : Dent X : Defective Y : Crack, Gap</p>
<p>Remarks (R) Front Seat - Grime - Medium / Rear Seat - Grime - Small / (L) Front Trim - Grime - Small / (L) Front Seat - Grime - Small / Ceiling - Grime - Minimal</p>	<p>Remarks (R) Front Fender - Repair Traces - Yes / Bonnet - Repair Traces - Yes / Trunk Hood, Rear Gate - Repair Traces - Yes / (R) Rear Door, Molding - Dent - Small / (R) Front Fender, Molding - Dent - Small / (R) Front Door, Molding - Scratch - Small / (R) Rear Fender, Molding - Scratch - Small / Rear Bumper, Lamps, Panels - Repair mark - Yes / Rear Bumper, Lamps, Panels - Scratch - Small / Trunk Hood, Rear Gate - Scratch - Minimal / (L) Rear Door, Molding - Dent - Small / (L) Rear Fender, Molding - Scratch - Small / (L) Step, In-panel, Side Spoiler - Scratch - Minimal / (L) Front Door, Molding - Scratch - Small / Front Bumper, Grille, Lamps - Scratch - Medium / Bonnet, Headlight - Scratch & Dent - Small / Roof - Dent - Small</p>
