General Information

Make	Toyota	Model	Wigo
YOM	2024	Odo Meter Reading	12,844
Registration No.	CCC9159	Chassis No.	MHKAA1BC6RJ018563
CC	1.0	Transmission	CVT
Fuel Type	Gas	Type of Body	Hatchback
Colour	Silver

Body / Panel Condition

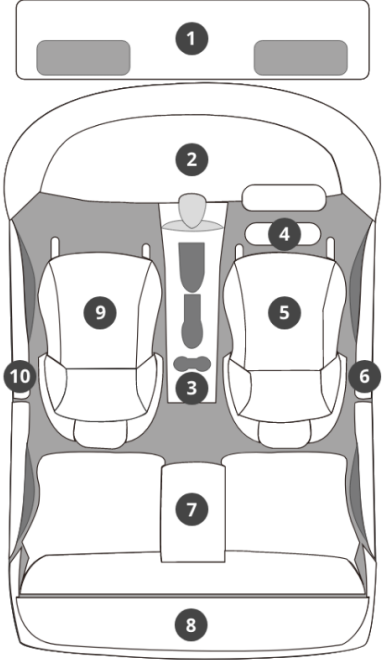
Interior Evaluation : A	Exterior Evaluation : A

<p>a : Cut, Fray d : Loose, Deformed k : Animal Hair s : Smell t : Cigarette Burns x : Defective y : Stain</p>

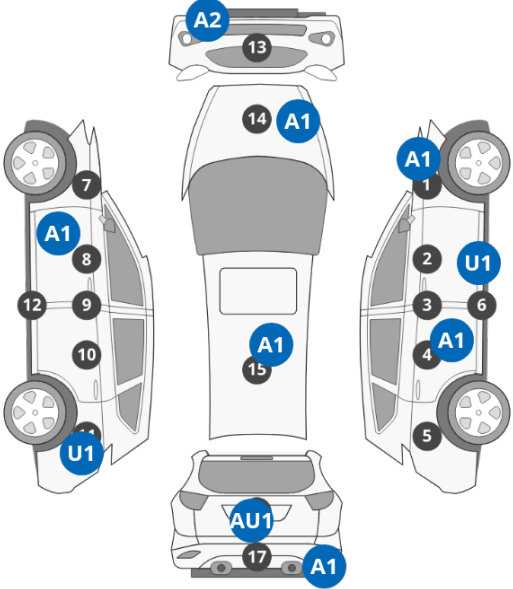
<p>A : Scratch AU : Scratch & Dent B : Modified C : Corrosion G : Stone chip P : Faded S : Rust SC : Rust & Corrosion U : Dent X : Defective Y : Crack, Gap</p>
<p>Remarks Defects not found</p>	<p>Remarks (L) Front Door, Molding - Scratch - Minimal / (L) Rear Fender, Molding - Dent - Minimal / (R) Front Fender, Molding - Scratch - Minimal / Bonnet, Headlight - Scratch - Minimal / Front Bumper, Grille, Lamps - Scratch - Small / Rear Bumper, Lamps, Panels - Scratch - Minimal / Trunk Hood, Rear Gate - Scratch & Dent - Minimal / (R) Rear Door, Molding - Scratch - Minimal / (R) Step, In-panel, Side Spoiler - Dent - Minimal / Roof - Scratch - Minimal</p>
Frame Evaluation : A	Functional Evaluation : A
<p>Remarks Defects not found</p>	<p>Remarks Defects not found</p>

<p>Inspector Notes</p>
<p>With LTO plate and Sparetire and Jack and Incomplete Tools, Warranty booklet. Scratch headlight and tail light.</p>
