General Information

Make	Toyota	Model	Vios
YOM	2023	Odo Meter Reading	23,984
Registration No.	NHR2213	Chassis No.	PA1B18F36P4223916
CC	1.3	Transmission	CVT
Fuel Type	Gas	Type of Body	Sedan
Colour	Blue

Body / Panel Condition

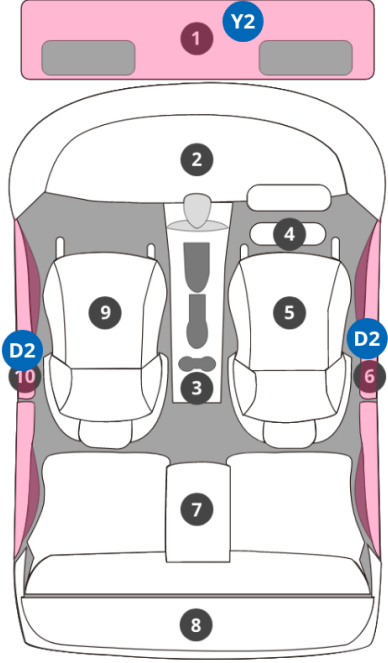
Interior Evaluation : A	Exterior Evaluation : E

<p>a : Cut, Fray d : Loose, Deformed k : Animal Hair s : Smell t : Cigarette Burns x : Defective y : Stain</p>

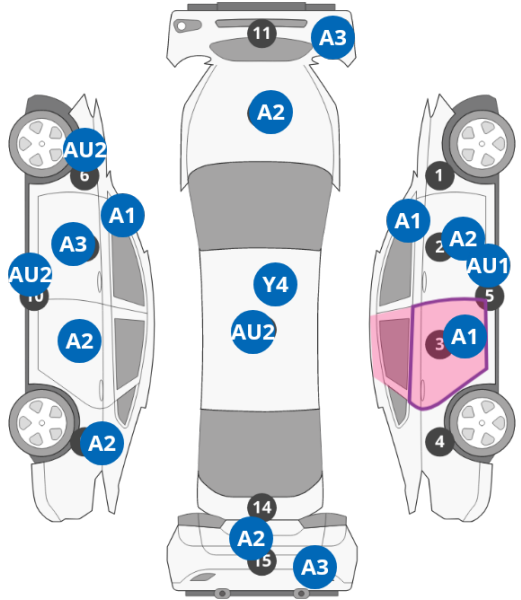
<p>A : Scratch AU : Scratch & Dent B : Modified C : Corrosion G : Stone chip P : Faded S : Rust SC : Rust & Corrosion U : Dent X : Defective Y : Crack, Gap</p>
<p>Remarks Ceiling - Grime - Small / (L) Front Trim - Worked - Small / (R) Front Trim - Worked - Small</p>	<p>Remarks (L) Rear Fender, Molding - Scratch - Small / (L) Front Door, Molding - Scratch - Medium / (L) Step, In-panel, Side Spoiler - Scratch & Dent - Small / (L) Front Fender, Molding - Scratch & Dent - Small / (L) Rear Door, Molding - Scratch - Small / (L) Mirror - Scratch - Minimal / Front Windshield - Damaged - Large / Front Bumper, Grille, Lamps - Scratch - Medium / Bonnet, Headlight - Scratch - Small / (R) Mirror - Scratch - Minimal / (R) Front Door, Molding - Scratch - Small / (R) Step, In-panel, Side Spoiler - Scratch & Dent - Minimal / (R) Rear Door, Molding - Repair mark - Yes / (R) Rear Door, Molding - Scratch - Minimal / Rear Bumper, Lamps, Panels - Scratch - Medium / Trunk Hood, Rear Gate - Scratch - Small / Roof - Scratch & Dent - Small</p>
