General Information

Make	Toyota	Model	Vios
YOM	2025	Odo Meter Reading	7,967
Registration No.	CCJ2866	Chassis No.	PA1B18F30R4278929
CC	1.3	Transmission	CVT
Fuel Type	Gas	Type of Body	Sedan
Colour	Black

Body / Panel Condition

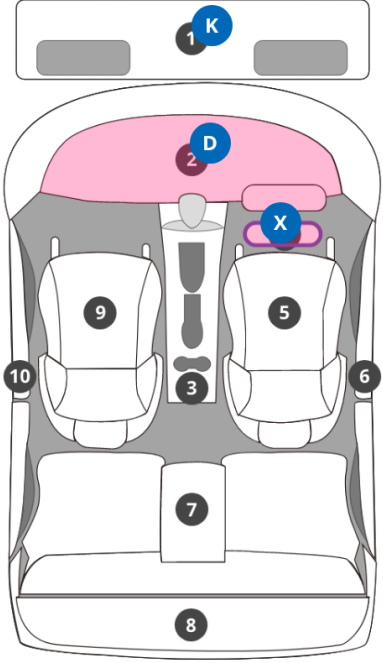
<p>a : Cut, Fray d : Loose, Deformed k : Animal Hair s : Smell t : Cigarette Burns x : Defective y : Stain</p>

<p>A : Scratch AU : Scratch & Dent B : Modified C : Corrosion G : Stone chip P : Faded S : Rust SC : Rust & Corrosion U : Dent X : Defective Y : Crack, Gap</p>
<p>Remarks (L) Front Floor Mat - Missing - Yes / Overall Interior - Animal Hair - Yes / Dashboard - Traces of Adhesive Tape - Yes</p>	<p>Remarks Bonnet, Headlight - Scratch - Minimal / (R) Front Fender, Molding - Scratch - Minimal / (R) Front Door, Molding - Scratch - Minimal / (R) Rear Door, Molding - Scratch - Minimal / Trunk Hood, Rear Gate - Scratch - Small / (L) Rear Fender, Molding - Scratch - Small / Roof - Scratch - Small / (L) Rear Door, Molding - Scratch - Minimal / (L) Front Door, Molding - Scratch - Small / (L) Mirror - Scratch - Minimal / (L) Front Fender, Molding - Scratch - Minimal / Front Bumper, Grille, Lamps - Scratch - Minimal / (R) Rear Fender, Molding - Scratch - Minimal</p>

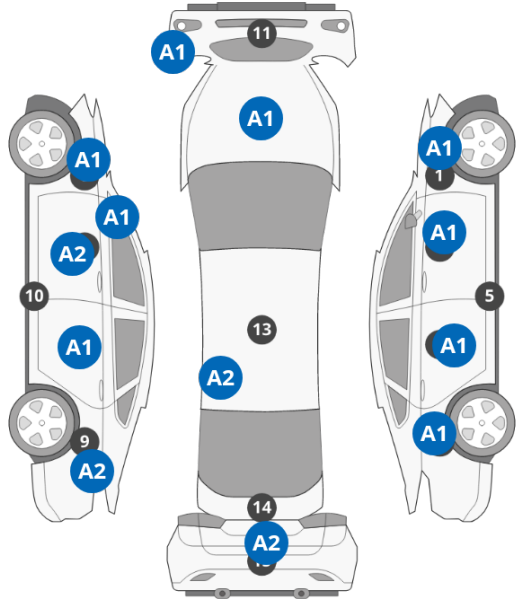
<p>Inspector Notes</p>
<p>With LTO plate and Sparetire and Jack and Incomplete Tools, No warranty booklet and No Spare key, Scratch headlight and tail light and plate light busted.</p>
