## General Information

| Make | Toyota | Model | Corolla Cross |

## Body / Panel Condition

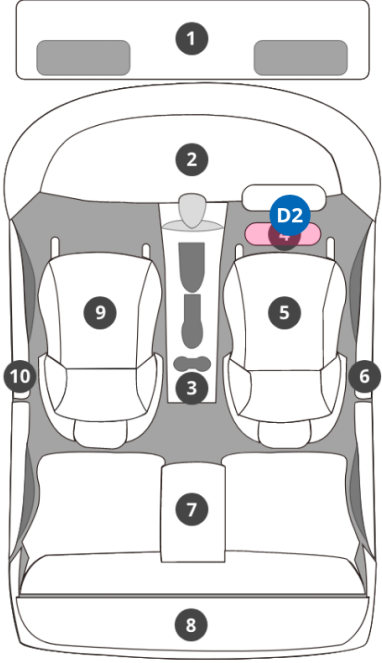
| Interior Evaluation : <span style="color: red; font-weight: bold;">A</span> | Exterior Evaluation : <span style="color: red; font-weight: bold;">A</span> |
| <b>Remarks</b><br>(L) Front Floor Mat - Worked - Small | <b>Remarks</b><br>(R) Rear Fender, Molding - Scratch - Small / Trunk Hood, Rear Gate - Scratch - Minimal / Roof - Scratch & Dent - Minimal / Bonnet, Headlight - Scratch - Minimal / Rear Bumper, Lamps, Panels - Scratch - Minimal / (L) Rear Fender, Molding - Scratch - Minimal / (L) Front Fender, Molding - Scratch - Minimal / Front Bumper, Grille, Lamps - Scratch - Minimal / (R) Front Door, Molding - Scratch - Minimal |

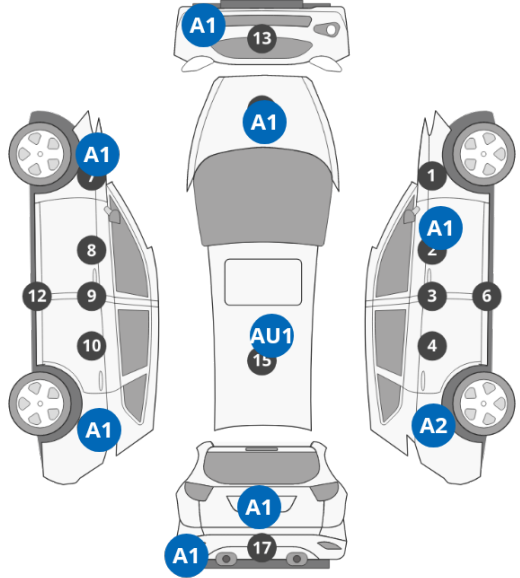
| Inspector Notes |
|---|
| With LTO plate and Sparetire and Jack and Incomplete Tools and warranty booklet, scratch headlight and tail light. |
