General Information

| Make | Toyota | Model | Vios |

Body / Panel Condition

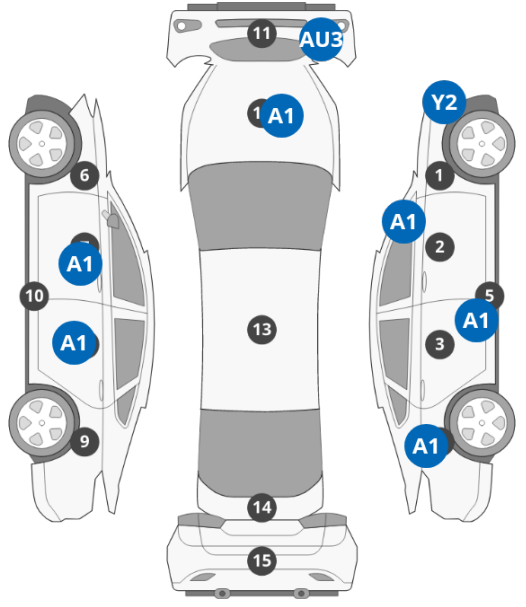
| <p>Remarks Defects not found</p> | | <p>Remarks Front Bumper, Grille, Lamps - Scratch & Dent - Medium / (R) Front Fender, Molding - Crack, Gap - Small / (R) Mirror - Scratch - Minimal / (R) Rear Door, Molding - Scratch - Minimal / (R) Rear Fender, Molding - Scratch - Minimal / (L) Rear Door, Molding - Scratch - Minimal / (L) Front Door, Molding - Scratch - Minimal / Bonnet, Headlight - Scratch - Minimal</p> | |

| <p>With LTO plate and Jack, No Tools and warranty booklet and Sparetire, Scratch headlight and tail light.</p> |
