General Information

Make	Toyota	Model	Vios
YOM	2024	Odo Meter Reading	10,128
Registration No.	CCA8304	Chassis No.	PA1B18F37R4259990
CC	1.3	Transmission	CVT
Fuel Type	Gas	Type of Body	Sedan
Colour	Blue

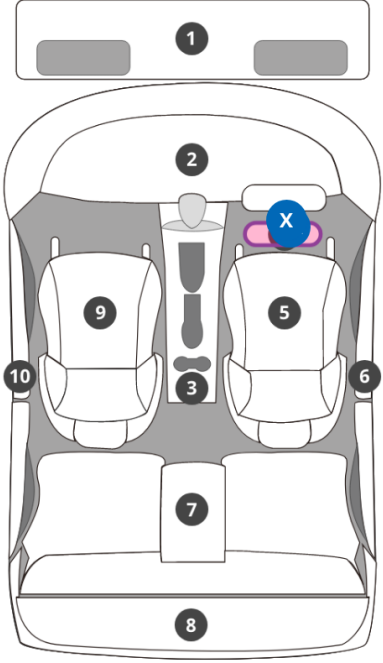
Interior Evaluation : B	Exterior Evaluation : B

<p>a : Cut, Fray d : Loose, Deformed k : Animal Hair s : Smell t : Cigarette Burns x : Defective y : Stain</p>

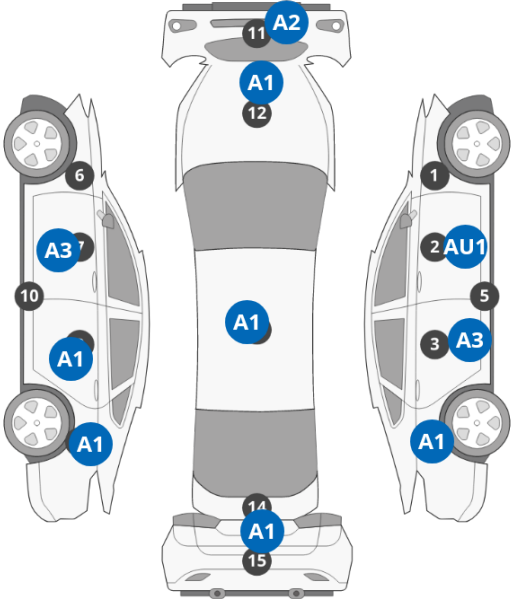
<p>A : Scratch AU : Scratch & Dent B : Modified C : Corrosion G : Stone chip P : Faded S : Rust SC : Rust & Corrosion U : Dent X : Defective Y : Crack, Gap</p>
<p>Remarks (L) Front Floor Mat - Worked - Small / (R) Front Floor Mat - Missing - Yes</p>	<p>Remarks (L) Front Door, Molding - Scratch - Medium / (L) Rear Door, Molding - Scratch - Minimal / Front Bumper, Grille, Lamps - Scratch - Small / (R) Front Door, Molding - Scratch & Dent - Minimal / (R) Rear Door, Molding - Scratch - Medium / (R) Rear Fender, Molding - Scratch - Minimal / Trunk Hood, Rear Gate - Scratch - Minimal / (L) Rear Fender, Molding - Scratch - Minimal / Roof - Scratch - Minimal / Bonnet, Headlight - Scratch - Minimal</p>
Frame Evaluation : A	Functional Evaluation : A

<p>Inspector Notes</p>
<p>With LTO plate and warranty booklet, No Tools and Jack and Sparetire, No spare key and scratch headlight and tail light.</p>
