## General Information

| Make | Toyota | Model | Vios |
| YOM | 2024 | Odo Meter Reading | 74,463 |

## Body / Panel Condition

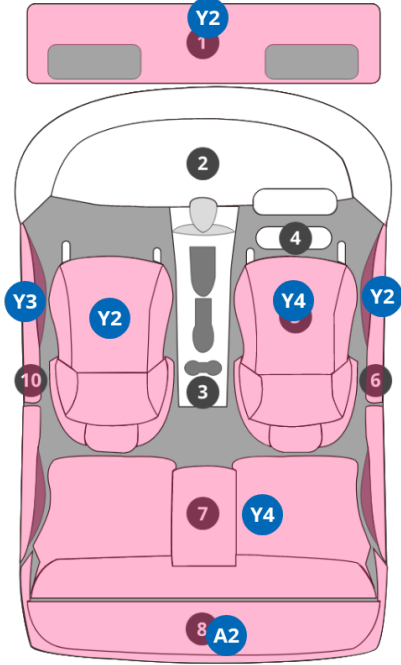
| Interior Evaluation : <b>C</b> | Exterior Evaluation : <b>E</b> |
| <p><b>Remarks</b><br/>(R) Front Trim - Grime - Small / (R) Front Seat - Grime - Large / Rear Seat - Grime - Large / Trunk Room - Worn, Scratch, Cut, Crack - Small / (L) Front Trim - Grime - Medium / (L) Front Seat - Grime - Small / Ceiling - Grime - Small</p> | <p><b>Remarks</b><br/>(L) Rear Door, Molding - Scratch - Medium / (L) Front Door, Molding - Scratch - Medium / (L) Mirror - Scratch - Minimal / (L) Front Fender, Molding - Scratch - Small / Bonnet, Headlight - Scratch - Small / Front Bumper, Grille, Lamps - Scratch - Large / (L) Step, In-panel, Side Spoiler - Scratch &amp; Dent - Medium / Rear Bumper, Lamps, Panels - Scratch - Medium / Trunk Hood, Rear Gate - Scratch &amp; Dent - Small / (R) Rear Fender, Molding - Scratch - Small / (L) Rear Fender, Molding - Scratch - Minimal / (R) Rear Door, Molding - Scratch - Minimal / (R) Front Door, Molding - Scratch - Medium / (R) Mirror - Scratch - Minimal / (R) Front Fender, Molding - Scratch - Minimal / Roof - Scratch - Minimal</p> |
