## General Information

<b>Make</b>	Toyota	<b>Model</b>	Vios
<b>YOM</b>	2025	<b>Odo Meter Reading</b>	19,119
<b>Registration No.</b>	DBQ4570	<b>Chassis No.</b>	PA1B18F39R4269517
<b>CC</b>	1.3	<b>Transmission</b>	CVT
<b>Fuel Type</b>	Gas	<b>Type of Body</b>	Sedan
<b>Colour</b>	Blue

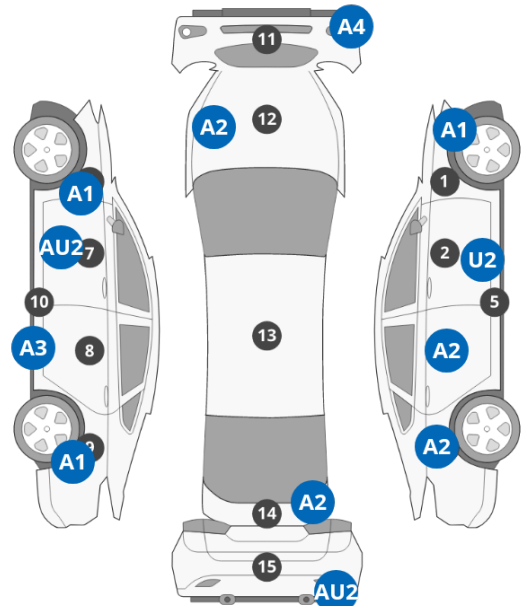
<p><b>A :</b> Scratch <b>AU :</b> Scratch &amp; Dent <b>B :</b> Modified <b>C :</b> Corrosion <b>G :</b> Stone chip <b>P :</b> Faded <b>S :</b> Rust <b>SC :</b> Rust &amp; Corrosion <b>U :</b> Dent <b>X :</b> Defective <b>Y :</b> Crack, Gap</p>
<p><b>Remarks</b> Rear Seat - Grime - Medium / Mat Other - Grime - Large / (R) Front Seat - Grime - Small / (L) Front Trim - Grime - Small / (L) Front Floor Mat - Worked - Large / (L) Front Trim - Worked - Small</p>	<p><b>Remarks</b> (R) Front Door, Molding - Dent - Small / Rear Bumper, Lamps, Panels - Scratch &amp; Dent - Small / (L) Front Door, Molding - Scratch &amp; Dent - Small / Front Bumper, Grille, Lamps - Scratch - Large / (R) Front Fender, Molding - Scratch - Minimal / (R) Rear Door, Molding - Scratch - Small / (R) Rear Fender, Molding - Scratch - Small / Trunk Hood, Rear Gate - Scratch - Small / (L) Rear Fender, Molding - Scratch - Minimal / (L) Step, In-panel, Side Spoiler - Scratch - Medium / Bonnet, Headlight - Scratch - Small / (L) Front Fender, Molding - Scratch - Minimal</p>
