## General Information

| Make | Toyota | Model | Vios |

## Body / Panel Condition

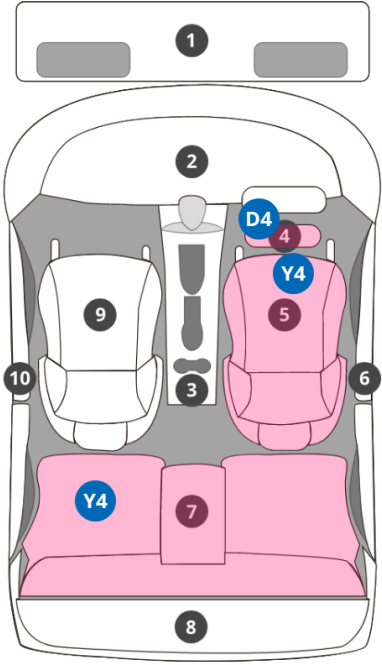
| Interior Evaluation : <span style="color: red;">C</span> | Exterior Evaluation : <span style="color: red;">C</span> |
| <b>Remarks</b><br>Rear Seat - Grime - Large / (R) Front Seat - Grime - Large / (L) Front Floor Mat - Worked - Large | <b>Remarks</b><br>Front Bumper, Grille, Lamps - Scratch & Dent - Large / (R) Rear Door, Molding - Dent - Small / (R) Rear Fender, Molding - Scratch - Medium / Rear Bumper, Lamps, Panels - Scratch - Medium / (L) Rear Fender, Molding - Scratch - Large / (L) Front Fender, Molding - Scratch - Small / (L) Rear Door, Molding - Scratch - Small / (L) Front Door, Molding - Scratch - Small / Trunk Hood, Rear Gate - Scratch - Small |
