## General Information

| Make | Toyota | Model | Veloz |

## Body / Panel Condition

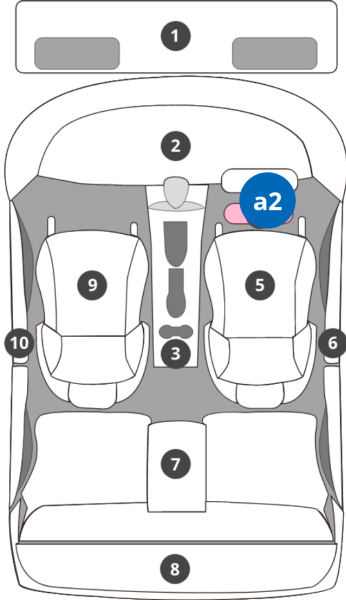
| Interior Evaluation : <span style="color: red;">A</span> | Exterior Evaluation : <span style="color: red;">B</span> |
| <b>Remarks</b><br>(L) Front Floor Mat - Cut, Crack - Small | <b>Remarks</b><br>(R) Rear Fender - Repair Traces - Yes / (R) Rear Fender, Molding - Repair mark - Yes / (R) Rear Fender, Molding - Scratch - Small / Rear Bumper, Lamps, Panels - Scratch & Dent - Medium / Front Bumper, Grille, Lamps - Scratch - Medium |
