## General Information

| Make | Toyota | Model | Vios |
| YOM | 2025 | Odo Meter Reading | 11,627 |
| Registration No. | DBT6115 | Chassis No. | PA1B18F36S4284174 |

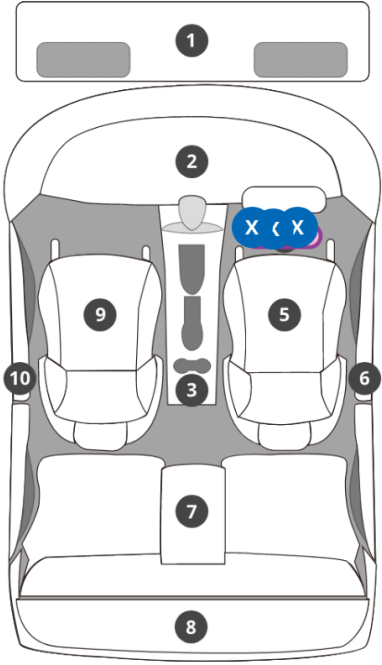
| Interior Evaluation : <b>B</b> | Exterior Evaluation : <b>A</b> |
|---|---|
| <b>Remarks</b><br>Mat Other - Missing - Yes / (L) Front Floor Mat - Missing - Yes / (R) Front Floor Mat - Missing - Yes | <b>Remarks</b><br>Defects not found |
