## General Information

| Make | Toyota | Model | Hilux |
| YOM | 2023 | Odo Meter Reading | 12,794 |
| Registration No. | EAG3127 | Chassis No. | MR0AB8DD2P5034613 |

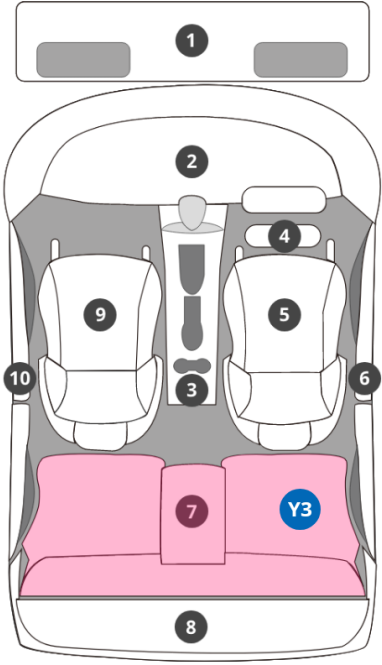
| Interior Evaluation : <b>B</b> | Exterior Evaluation : <b>C</b> |
|---|---|
| <b>Remarks</b><br>Rear Seat - Grime - Medium | <b>Remarks</b><br>Rear Gate - Dent - Small / (R) Side Gate - Scratch - Medium / (L) Rear Door, Molding - Dent - Small / (L) Front Door, Molding - Scratch - Small / (L) Side Gate - Scratch - Small / (L) Front Fender, Molding - Scratch - Small / Bonnet, Headlight - Scratch & Dent - Small / Rear Bumper, Lamps, Panels - Scratch & Dent - Medium / Front Bumper, Grille, Lamps - Scratch - Medium / (R) Step, In-panel, Side Spoiler - Scratch - Medium |
