General Information

Make	Toyota	Model	Vios
YOM	2025	Odo Meter Reading	2,535
Registration No.	NEB9797	Chassis No.	PA1B18F32S4288657
CC	1.3	Transmission	CVT
Fuel Type	Gas	Type of Body	Sedan
Colour	Red

Body / Panel Condition

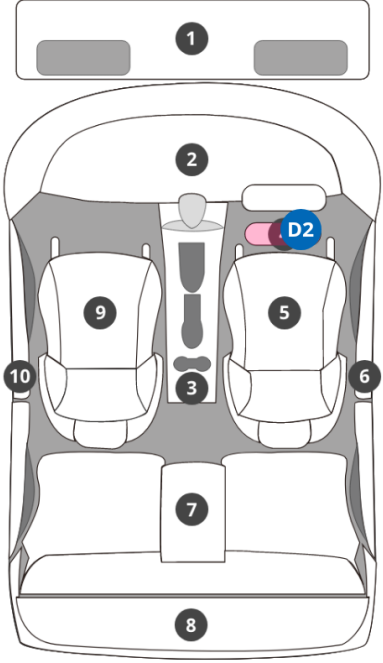
Interior Evaluation : A	Exterior Evaluation : A

<p>a : Cut, Fray d : Loose, Deformed k : Animal Hair s : Smell t : Cigarette Burns x : Defective y : Stain</p>

<p>A : Scratch AU : Scratch & Dent B : Modified C : Corrosion G : Stone chip P : Faded S : Rust SC : Rust & Corrosion U : Dent X : Defective Y : Crack, Gap</p>
Remarks (L) Front Floor Mat - Worked - Small	Remarks (L) Front Fender, Molding - Scratch - Minimal / (L) Front Door, Molding - Scratch - Minimal / (L) Rear Fender, Molding - Scratch - Minimal / Trunk Hood, Rear Gate - Scratch - Minimal / Bonnet, Headlight - Scratch - Minimal / (R) Front Door, Molding - Scratch - Minimal / (R) Step, In-panel, Side Spoiler - Scratch - Minimal / Roof - Scratch - Minimal / Front Bumper, Grille, Lamps - Scratch - Minimal
Frame Evaluation : A	Functional Evaluation : A
Remarks Defects not found	Remarks Defects not found
