## General Information

| Make | Toyota | Model | Lite Ace |
| Registration No. | NFR5781 | Chassis No. | MHKB3FE10RK003908 |

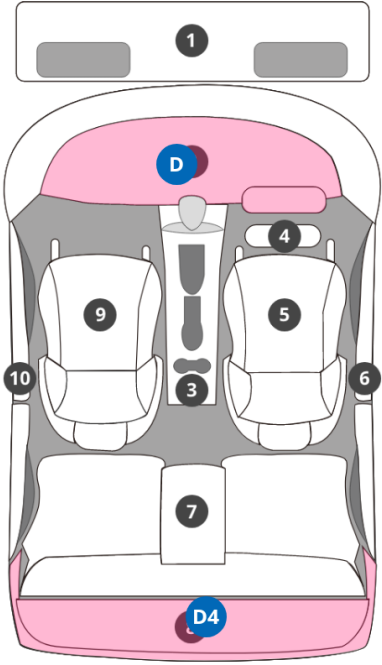
| Interior Evaluation : <span style="color: red;">C</span> | Exterior Evaluation : <span style="color: red;">D</span> |
| <b>Remarks</b><br>Dashboard - Traces of Adhesive Tape - Yes / Trunk Room - Loose, Deformed - Large | <b>Remarks</b><br>(R) Rear Fender - Repair Traces - Yes / Roof - Modified - Large / (R) Rear Fender, Molding - Repair mark - Yes / (R) Rear Door, Molding - Scratch - Medium / (R) Step, In-panel, Side Spoiler - Scratch & Dent - Small / (R) Front Door, Molding - Scratch - Small / (R) Front Fender, Molding - Scratch - Minimal / (L) Rear Door, Molding - Scratch & Dent - Small / (L) Rear Fender, Molding - Scratch - Medium / (L) Step, In-panel, Side Spoiler - Scratch - Small / Trunk Hood, Rear Gate - Scratch - Small / Rear Bumper, Lamps, Panels - Scratch - Small / (L) Front Door, Molding - Scratch - Small / Front Bumper, Grille, Lamps - Scratch - Small / Bonnet, Headlight - Dent - Small |
