## General Information

| Make | Toyota | Model | Avanza |

## Body / Panel Condition

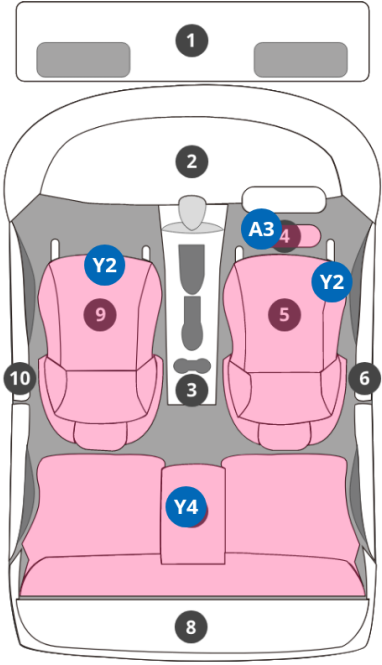
| Interior Evaluation : <span style="color: red; font-weight: bold;">C</span> | Exterior Evaluation : <span style="color: red; font-weight: bold;">E</span> |
| <b>Remarks</b><br>Rear Seat - Grime - Large / (R) Front Seat - Grime - Small / (L) Front Floor Mat - Cut, Crack - Medium / (L) Front Seat - Grime - Small | <b>Remarks</b><br>(R) Front Fender, Molding - Scratch & Dent - Large / Front Bumper, Grille, Lamps - Scratch & Dent - Large / (R) Front Door, Molding - Dent - Small / (R) Step, In-panel, Side Spoiler - Scratch - Large / (R) Rear Door, Molding - Scratch & Dent - Large / (R) Rear Fender, Molding - Scratch - Medium / Rear Bumper, Lamps, Panels - Scratch & Dent - Large / (L) Rear Fender, Molding - Scratch & Dent - Medium / Trunk Hood, Rear Gate - Scratch - Small / (L) Rear Door, Molding - Scratch - Small / (L) Front Door, Molding - Scratch - Small / (L) Front Fender, Molding - Scratch - Small / Bonnet, Headlight - Dent - Small |
