## General Information

| Make | Toyota | Model | Vios |
| YOM | 2023 | Odo Meter Reading | 52,090 |

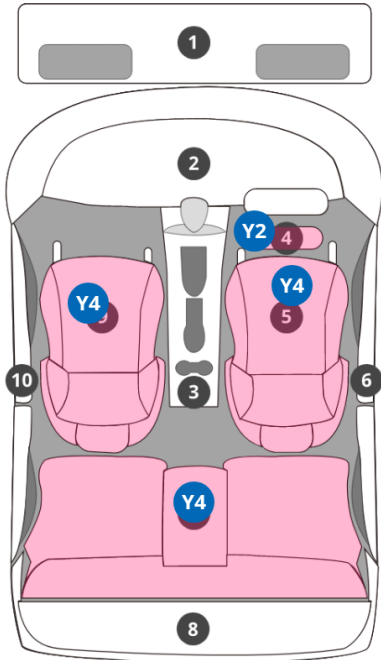
| Interior Evaluation : <span style="color: red; font-weight: bold;">C</span> | | Exterior Evaluation : <span style="color: red; font-weight: bold;">D</span> | |
| <p><b>Remarks</b></p> <p>Rear Seat - Grime - Large / (L) Front Seat - Grime - Large / (R) Front Seat - Grime - Large / (L) Front Floor Mat - Grime - Small</p> | | <p><b>Remarks</b></p> <p>Member (Bolted) - Dent - Yes / Front Bumper, Grille, Lamps - Scratch &amp; Dent - Large / (L) Rear Door, Molding - Dent - Small / (L) Front Fender, Molding - Scratch - Small / (L) Front Door, Molding - Scratch - Small / (L) Rear Fender, Molding - Scratch - Minimal / Trunk Hood, Rear Gate - Modified - Large / Rear Bumper, Lamps, Panels - Scratch &amp; Dent - Large / (R) Rear Fender, Molding - Scratch - Small / (R) Rear Door, Molding - Scratch - Medium / (R) Front Door, Molding - Scratch &amp; Dent - Small / (R) Front Fender, Molding - Scratch - Minimal / Bonnet, Headlight - Scratch - Minimal</p> | |
