## General Information

| Make | Toyota | Model | Hilux |

## Body / Panel Condition

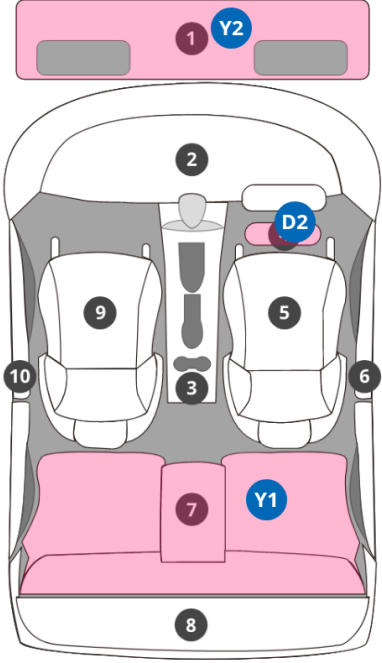
| Interior Evaluation : <b>A</b> | Exterior Evaluation : <b>C</b> |
| <b>Remarks</b><br>Rear Seat - Grime - Minimal / Ceiling - Grime - Small / (L) Front Floor Mat - Worked - Small | <b>Remarks</b><br>Rear Bumper, Lamps, Panels - Scratch & Dent - Small / Cargo Bed Floor - Scratch - Small / Cab Back Panel - Scratch & Dent - Small / Roof - Scratch & Dent - Small / Bonnet, Headlight - Scratch & Dent - Minimal / Front Bumper, Grille, Lamps - Scratch - Small / Member (Bolted) - Dent - Yes / (R) Side Gate - Scratch - Small / (L) Side Gate - Scratch - Small / (L) Rear Wheel, Cover - Cap Missing - Yes / (R) Rear Wheel, Cover - Cap Missing - Yes / (L) Front Wheel, Cover - Cap Missing - Yes / (R) Front Wheel, Cover - Cap Missing - Yes / (L) Front Fender, Molding - Scratch - Minimal / (L) Mirror - Scratch - Minimal / (R) Mirror - Scratch - Minimal / (R) Front Door, Molding - Scratch - Minimal / (L) Front Door, Molding - Scratch - Minimal / (L) Rear Door, Molding - Scratch - Minimal / (R) Rear Door, Molding - Scratch - Minimal / (R) Front Fender, Molding - Scratch - Minimal |
