## General Information

| Make | Toyota | Model | Vios |

## Body / Panel Condition

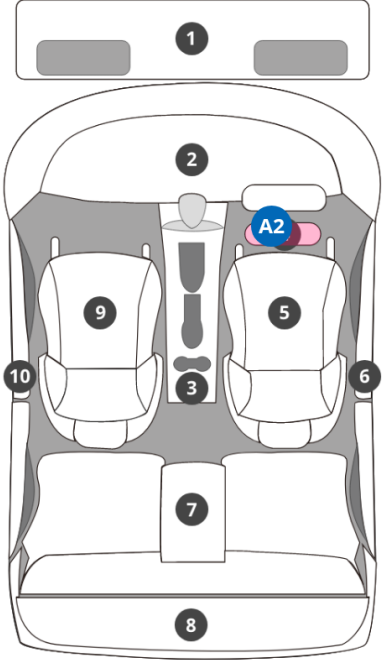
| Interior Evaluation : <span style="color: red; font-weight: bold;">A</span> | Exterior Evaluation : <span style="color: red; font-weight: bold;">C</span> |
|---|---|
| <b>Remarks</b><br>(L) Front Floor Mat - Cut, Crack - Small | <b>Remarks</b><br>Rear Bumper, Lamps, Panels - Scratch - Small / (R) Front Door, Molding - Dent - Small / (R) Front Fender, Molding - Scratch & Dent - Minimal / (R) Rear Door, Molding - Scratch & Dent - Small / (L) Rear Door, Molding - Dent - Small / Front Bumper, Grille, Lamps - Scratch - Small / (L) Front Fender, Molding - Scratch - Small / Roof - Dent - Small / (L) Front Door, Molding - Scratch - Small / (L) Rear Fender, Molding - Dent - Small / (R) Rear Fender, Molding - Scratch - Minimal |
