## General Information

| Make | Toyota | Model | Vios |
| Registration No. | NHM8375 | Chassis No. | PA1B18F31R4243686 |

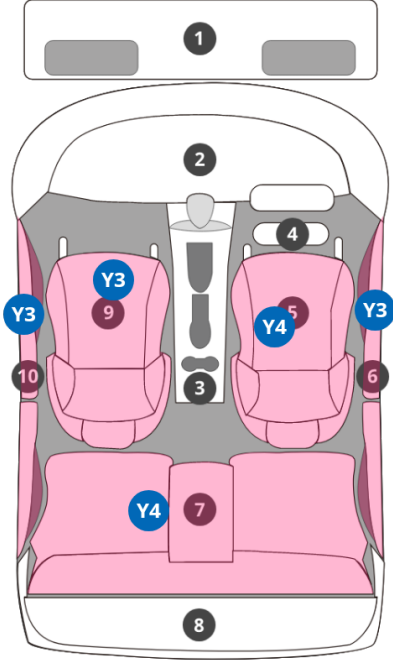
| Interior Evaluation : <b>C</b> | Exterior Evaluation : <b>C</b> |
|---|---|
| <p><b>Remarks</b><br/>Rear Seat - Grime - Large / (R) Front Trim - Grime - Medium / (R) Front Seat - Grime - Large / (L) Front Seat - Grime - Medium / (L) Front Trim - Grime - Medium</p> | <p><b>Remarks</b><br/>(L) Front Fender, Molding - Dent - Medium / Front Bumper, Grille, Lamps - Scratch - Medium / (R) Rear Door, Molding - Scratch - Minimal / (R) Front Door, Molding - Dent - Small / (R) Front Fender, Molding - Scratch - Small / Rear Bumper, Lamps, Panels - Crack, Gap - Small / (L) Rear Fender, Molding - Scratch - Large / (L) Front Door, Molding - Scratch - Small / (L) Rear Door, Molding - Scratch - Small / (R) Rear Fender, Molding - Scratch - Small</p> |
