## General Information

| Make | Toyota | Model | Vios |
| YOM | 2024 | Odo Meter Reading | 44,633 |
| Registration No. | NHS3237 | Chassis No. | PA1B18F37R4260816 |

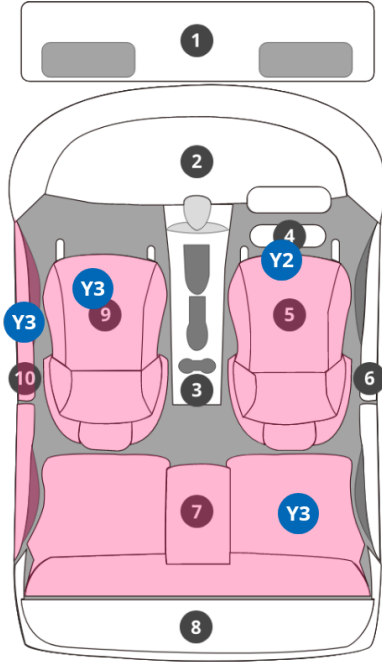
| Interior Evaluation : <b>B</b> | Exterior Evaluation : <b>C</b> |
| <b>Remarks</b><br>(L) Front Trim - Grime - Medium / (L) Front Seat - Grime - Medium / Rear Seat - Grime - Medium / (R) Front Seat - Grime - Small | <b>Remarks</b><br>Front Bumper, Grille, Lamps - Scratch & Dent - Large / (L) Front Door, Molding - Dent - Small / (R) Rear Door, Molding - Scratch - Medium / (R) Front Door, Molding - Scratch - Small / Rear Bumper, Lamps, Panels - Scratch - Medium / (L) Rear Fender, Molding - Scratch - Medium / (L) Rear Door, Molding - Scratch - Medium |
