## General Information

| Make | Toyota | Model | Vios |
| Registration No. | NHU7080 | Chassis No. | PA1B18F35R4275721 |

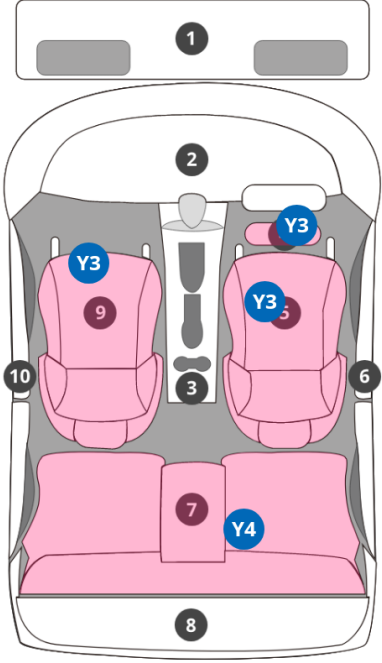
| Interior Evaluation : <b>C</b> | Exterior Evaluation : <b>C</b> |
|---|---|
| <p><b>Remarks</b><br/>Rear Seat - Grime - Large / (R) Front Seat - Grime - Medium / (L) Front Seat - Grime - Medium / (L) Front Floor Mat - Grime - Medium</p> | <p><b>Remarks</b><br/>(L) Rear Door - Repair Traces - Yes / (L) Rear Door, Molding - Scratch - Medium / Trunk Hood, Rear Gate - Scratch - Small / (R) Step, In-panel, Side Spoiler - Scratch &amp; Dent - Large / (L) Rear Fender, Molding - Scratch - Minimal / (L) Front Fender, Molding - Scratch - Minimal / (R) Front Fender, Molding - Scratch - Small / (R) Rear Door, Molding - Scratch - Minimal / (R) Front Door, Molding - Scratch - Minimal / (R) Rear Fender, Molding - Scratch - Small / Rear Bumper, Lamps, Panels - Scratch - Minimal / Front Bumper, Grille, Lamps - Scratch - Small</p> |
