## General Information

| Make | Toyota | Model | Vios |

## Body / Panel Condition

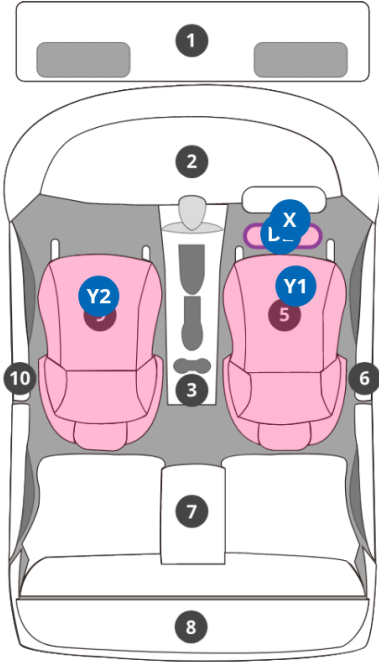
| Interior Evaluation : <b>B</b> | Exterior Evaluation : <b>B</b> |
|---|---|
| <b>Remarks</b><br>(L) Front Floor Mat - Worked - Small / Mat Other - Missing - Yes / (L) Front Seat - Grime - Small / (R) Front Seat - Grime - Minimal | <b>Remarks</b><br>(L) Step, In-panel, Side Spoiler - Scratch - Small / Bonnet, Headlight - Scratch - Small / Front Bumper, Grille, Lamps - Scratch - Minimal / (R) Rear Door, Molding - Scratch - Small / Trunk Hood, Rear Gate - Scratch - Small / Roof - Scratch - Small |
