## General Information

| Make | Toyota | Model | Avanza |
| YOM | 2023 | Odo Meter Reading | 4,093 |

## Body / Panel Condition

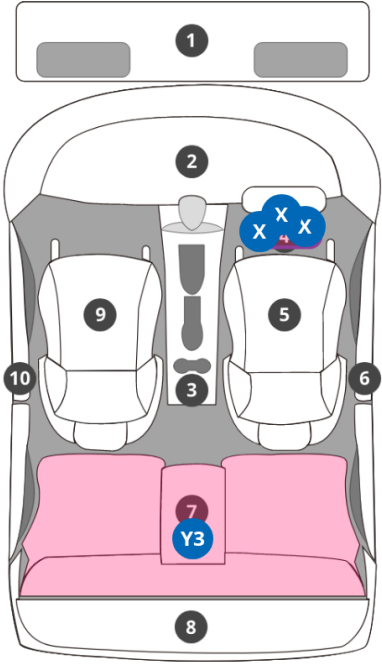
| Interior Evaluation : <b>B</b> | Exterior Evaluation : <b>E</b> |
| <p><b>Remarks</b><br/>Rear Seat - Grime - Medium / Mat Other - Missing - Yes / (L) Front Floor Mat - Missing - Yes / (R) Front Floor Mat - Missing - Yes</p> | <p><b>Remarks</b><br/>Rear Bumper, Lamps, Panels - Scratch &amp; Dent - Large / (L) Rear Fender, Molding - Scratch - Medium / Trunk Hood, Rear Gate - Scratch - Medium / (L) Front Door, Molding - Scratch - Large / (L) Rear Door, Molding - Scratch - Large / (L) Front Fender, Molding - Scratch - Small / Front Bumper, Grille, Lamps - Scratch - Large / Bonnet, Headlight - Scratch - Small / (R) Front Fender, Molding - Scratch - Small / (R) Front Door, Molding - Scratch - Minimal / (R) Step, In-panel, Side Spoiler - Scratch &amp; Dent - Large / (R) Rear Door, Molding - Scratch - Medium / Roof - Scratch - Small / (R) Rear Fender, Molding - Scratch - Small</p> |
