General Information

Make	Toyota	Model	Vios
YOM	2023	Odo Meter Reading	48,448
Registration No.	NII5393	Chassis No.	PA1B18F3F39P4200694
CC	1.3	Transmission	CVT
Fuel Type	Gas	Type of Body	Sedan
Colour	Blackish Red Mica

Body / Panel Condition

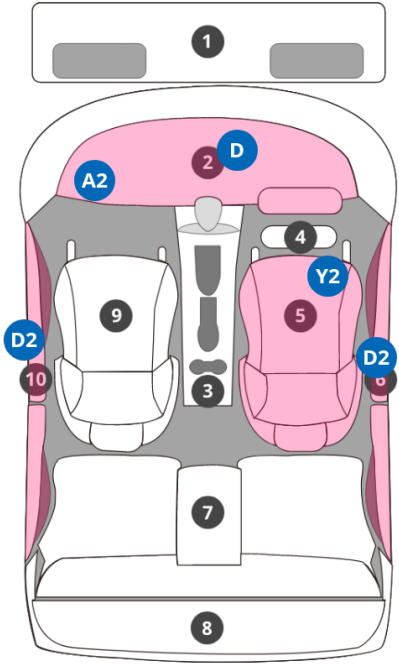
<p>a : Cut, Fray d : Loose, Deformed k : Animal Hair s : Smell t : Cigarette Burns x : Defective y : Stain</p>

<p>A : Scratch AU : Scratch & Dent B : Modified C : Corrosion G : Stone chip P : Faded S : Rust SC : Rust & Corrosion U : Dent X : Defective Y : Crack, Gap</p>
<p>Remarks (R) Front Seat - Grime - Small / Dashboard - Traces of Adhesive Tape - Yes / Steering Wheel - Worn, Peel, Crack - Small / (L) Front Trim - Worked - Small / (R) Front Trim - Worked - Small</p>	<p>Remarks (L) Rear Fender, Molding - Scratch - Medium / Rear Bumper, Lamps, Panels - Scratch - Medium / (L) Rear Door, Molding - Scratch & Dent - Minimal / (L) Front Door, Molding - Scratch - Small / (L) Mirror - Scratch - Minimal / (L) Front Fender, Molding - Scratch - Minimal / Bonnet, Headlight - Scratch - Minimal / Front Bumper, Grille, Lamps - Scratch & Dent - Minimal / (R) Front Fender, Molding - Scratch - Minimal / (R) Front Door, Molding - Scratch - Minimal / (R) Rear Door, Molding - Scratch - Minimal / (R) Rear Fender, Molding - Scratch & Dent - Minimal / Roof - Scratch - Minimal / Trunk Hood, Rear Gate - Scratch - Minimal</p>
