## General Information

| Make | Toyota | Model | Vios |
| Registration No. | NKH9748 | Chassis No. | PA1B18F32P4219796 |

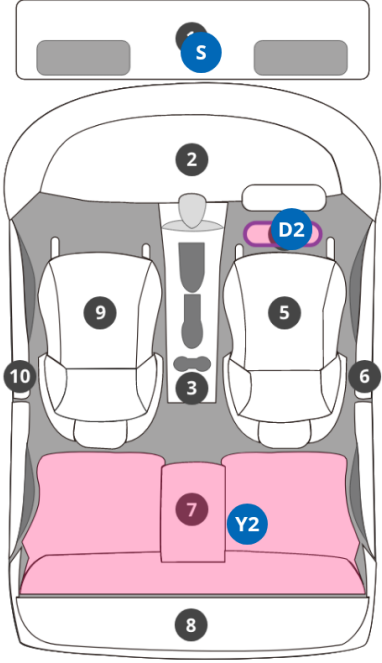
| Interior Evaluation : <b>B</b> | Exterior Evaluation : <b>C</b> |
| <b>Remarks</b><br>Mat Other - Missing - Yes / Rear Seat - Grime - Small / (L) Front Floor Mat - Worked - Small / Overall Interior - Smell - Yes | <b>Remarks</b><br>Bonnet - Repair Traces - Yes / Roof - Repair Traces - Yes / Bonnet, Headlight - Repair mark - Yes / Roof - Repair mark - Yes / (L) Rear Fender, Molding - Scratch - Minimal / (L) Rear Door, Molding - Scratch - Minimal / (L) Step, In-panel, Side Spoiler - Scratch & Dent - Minimal / (L) Front Door, Molding - Scratch - Minimal / (L) Front Fender, Molding - Scratch - Minimal / (L) Mirror - Scratch - Minimal / Member (Bolted) - Dent - Yes / Bonnet, Headlight - Scratch - Small / Front Bumper, Grille, Lamps - Scratch - Small / (R) Front Fender, Molding - Scratch & Dent - Minimal / (R) Mirror - Scratch - Minimal / (R) Front Door, Molding - Scratch - Small / (R) Rear Door, Molding - Scratch & Dent - Minimal / (R) Rear Fender, Molding - Scratch - Minimal / (R) Step, In-panel, Side Spoiler - Scratch - Minimal / Trunk Hood, Rear Gate - Scratch - Minimal / Rear Bumper, Lamps, Panels - Scratch - Small / Roof - Scratch & Dent - Minimal |
