General Information

Make	Toyota	Model	Lite Ace
YOM	2022	Odo Meter Reading	13,701
Registration No.	DBI7724	Chassis No.	MHKU3FE10NK000979
CC	1.5	Transmission	M/T
Fuel Type	Gas	Type of Body	Utility Cargo
Colour	White

Body / Panel Condition

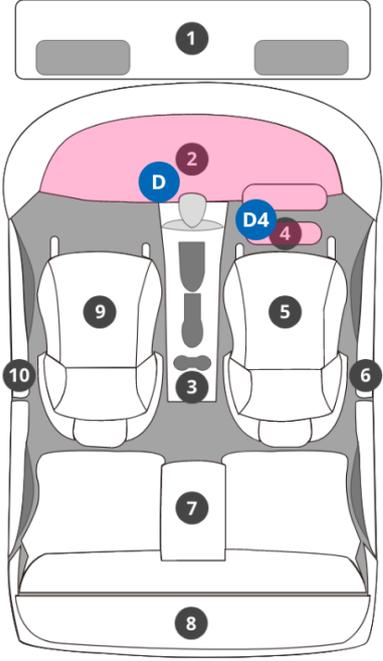
Interior Evaluation : C	Exterior Evaluation : E

<p>a : Cut, Fray d : Loose, Deformed k : Animal Hair s : Smell t : Cigarette Burns x : Defective y : Stain</p>

<p>A : Scratch AU : Scratch & Dent B : Modified C : Corrosion G : Stone chip P : Faded S : Rust SC : Rust & Corrosion U : Dent X : Defective Y : Crack, Gap</p>
Remarks Carpet - Worked - Large / Dashboard - Traces of Adhesive Tape - Yes	Remarks Front Bumper, Grille, Lamps - Scratch & Dent - Large / (L) Side Gate - Scratch & Dent - Large / Rear Gate - Scratch & Dent - Large / (R) Side Gate - Scratch & Dent - Large / (R) Front Door, Molding - Scratch - Large / (R) Front Fender, Molding - Scratch - Minimal / Bonnet, Headlight - Scratch - Small / (L) Front Fender, Molding - Scratch - Small / (L) Front Door, Molding - Scratch - Small / Rear Bumper, Lamps, Panels - Rust, Corrosion - Large
Frame Evaluation : A	Functional Evaluation : A
