General Information

Make	Toyota	Model	Innova
YOM	2021	Odo Meter Reading	228,242
Registration No.	NEM8557	Chassis No.	PA2JA8EM5M0098038
CC	2.8	Transmission	A/T
Fuel Type	Diesel	Type of Body	Wagon
Colour	Red Mica Metallic

Body / Panel Condition

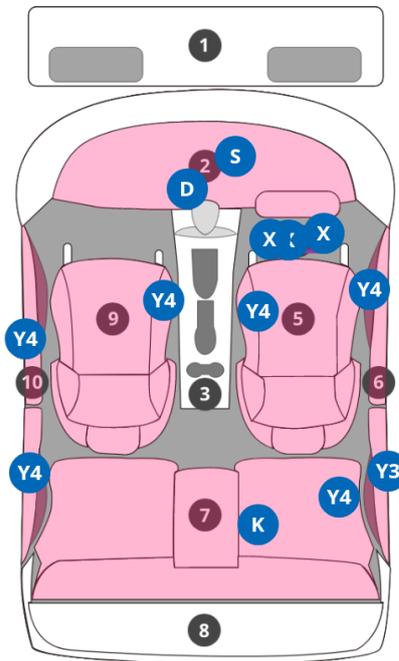
Interior Evaluation : E	Exterior Evaluation : E

<p>a : Cut, Fray d : Loose, Deformed k : Animal Hair s : Smell t : Cigarette Burns x : Defective y : Stain</p>

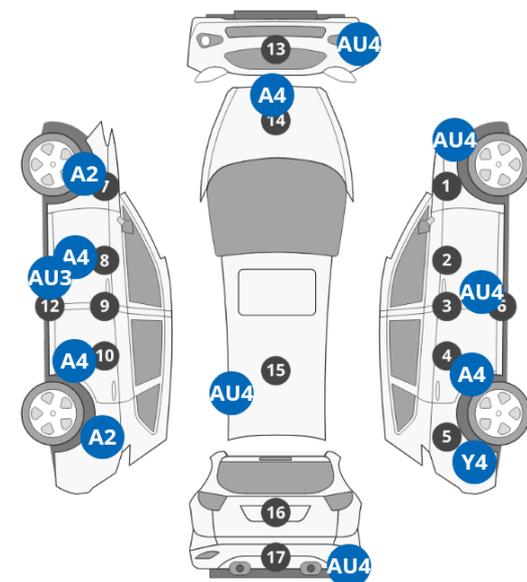
<p>A : Scratch AU : Scratch & Dent B : Modified C : Corrosion G : Stone chip P : Faded S : Rust SC : Rust & Corrosion U : Dent X : Defective Y : Crack, Gap</p>
<p>Remarks Overall Interior - Smell - Yes / Overall Interior - Animal Hair - Yes / (L) Front Floor Mat - Missing - Yes / (R) Front Floor Mat - Missing - Yes / Mat Other - Missing - Yes / Rear Seat - Grime - Large / (R) Rear Trim - Grime - Medium / (L) Rear Trim - Grime - Large / (L) Front Trim - Grime - Large / (R) Front Trim - Grime - Large / (R) Front Seat - Grime - Large / (L) Front Seat - Grime - Large / Dashboard - Traces of Adhesive Tape - Yes</p>	<p>Remarks Front Bumper, Grille, Lamps - Scratch & Dent - Large / (R) Front Fender, Molding - Scratch & Dent - Large / (R) Front Door, Molding - Scratch & Dent - Large / (R) Rear Door, Molding - Scratch - Large / (R) Rear Fender, Molding - Crack, Gap - Large / Rear Bumper, Lamps, Panels - Scratch & Dent - Large / Roof - Scratch & Dent - Large / (L) Rear Fender, Molding - Scratch - Small / (L) Rear Door, Molding - Scratch - Large / (L) Front Door, Molding - Scratch - Large / (L) Step, In-panel, Side Spoiler - Scratch & Dent - Medium / (L) Front Fender, Molding - Scratch - Small / Bonnet, Headlight - Scratch - Large</p>
